# ZE500CL(Virgo) EE

## Trouble Shooting Guide

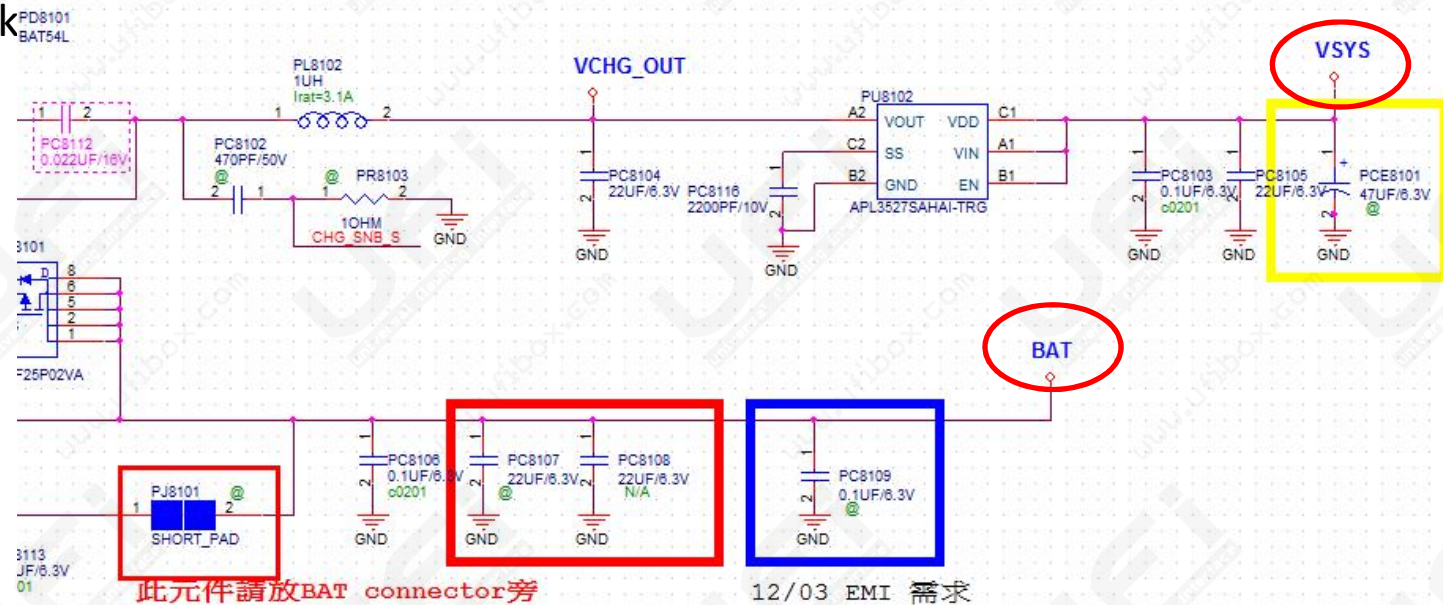
# Can not Power ON-1

- If Battery insert and don't press power on appears great current, check all components polar and X-Ray status. Check power on sequence of PMIC, see if any power rail short to others.
- When press power key cannot power on, check R2805.1(PMU\_ONKEY#) is Low signal.
- When Battery insert, check PC8105.1(VSYS), it should be close to battery voltage, if not, check

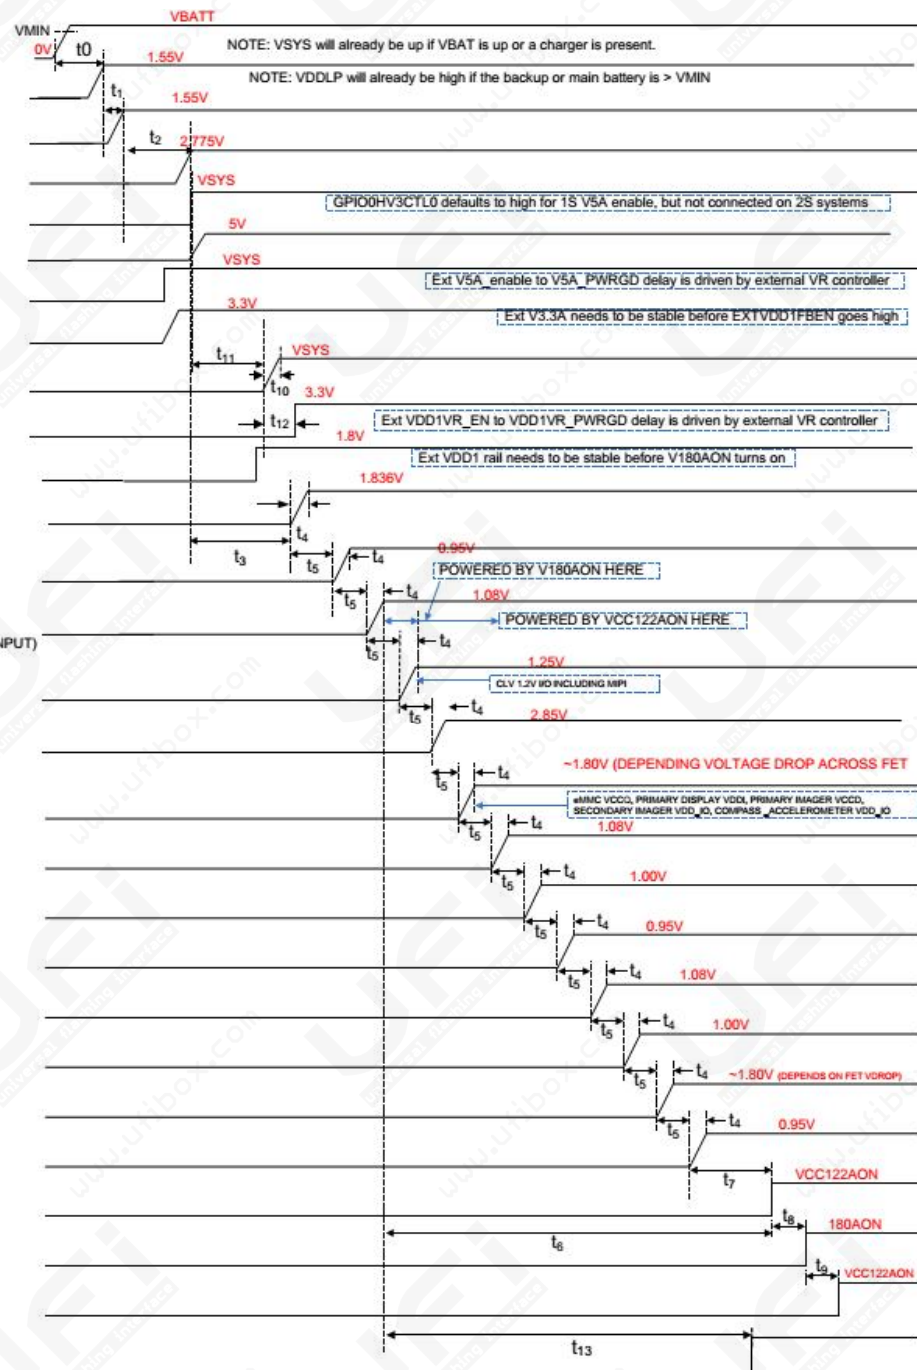
# PMIC Power On Sequence

- PC8105.1 VSYS
- PC8516.1 VDDL
- PC8517.1 VMSIC
- PC8514.1 VCORE
- PR8301.1 GPIO0HV3CTL0  
(enables ext V5A)  
Ext V5A  
Ext V5A\_PWRGD
- PC8305.1 Ext V3.3A
- EXTVDD1FBEN
- EXTVDD1VREN
- Ext VDD1
- PC8417.1 V180AON
- PC8412.1 VNNAON
- PC8520.1 VCC108AON  
(LDO W/ FET SWITCHED INPUT)
- PC8415.1 VCC122AON
- PC8529.1 VEMMC1, VEMMC2
- PC8531.1 VCC180AON  
(FET SWITCHED)
- PC8523.1 VCC108AS
- PC8522.1 VCCA100AS
- PC8408.1 VNN
- PC8519.1 VCC108
- PC8521.1 VCCA100  
VCC180  
(FET SWITCHED)
- PC8403.1 VCC
- T0612 PWRGD
- SDWN#
- PR8620.1 RESET#
- BBR8.1 MODEM\_RST#

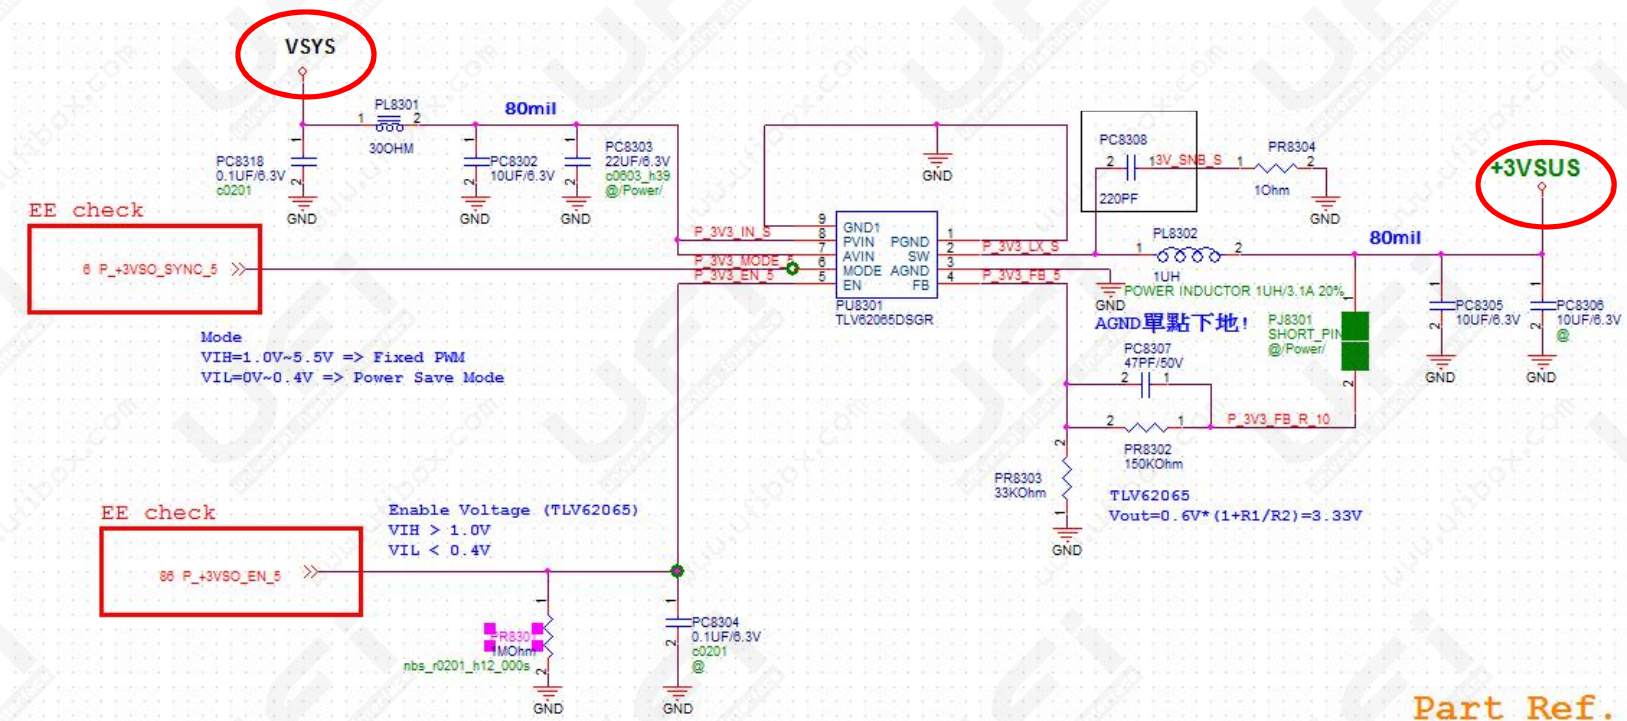
# Can not Power ON-2

- EXT 3.3VA is external power rail, +3VSUS.
- Check PU8301 SMT polar and PL8301, PL8302 solder status.
- When Press power key check PR8301.1(P\_+3VSO\_EN\_5) is High, if not, please check PMIC(PU8401).
- When PR8301.1 is high, PC8305.1 should output 3.3V, if not please check PU8301.

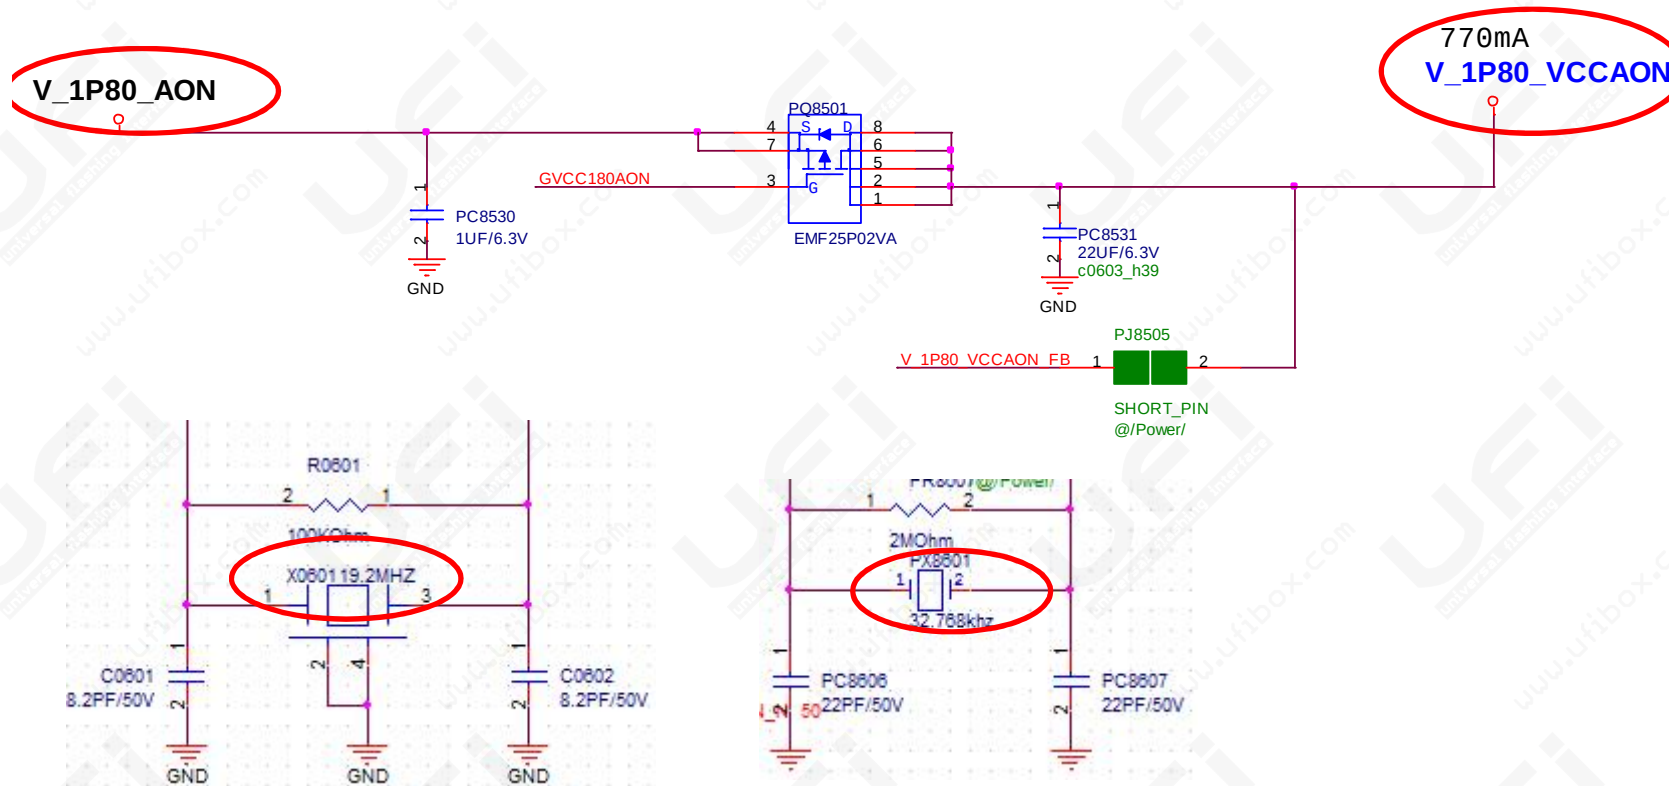
# Can not Power ON-3

- If V\_1P80\_VCCAON is not appears 1.8V, please check polarity and SMT of PQ8501 and PMIC (PU8401).
- Check C0601.1 is 19.2MHz or not. Check PC8606.1 is 32.768kHz or not.

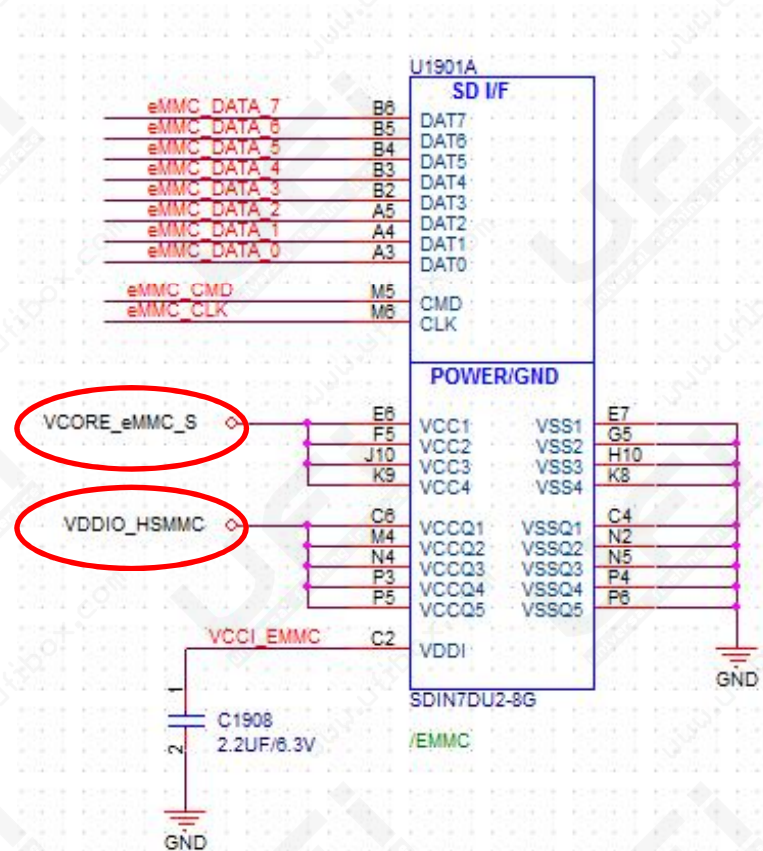
# Can not Power ON-4

- If power rails and status of PMIC (PU8401) all fine, then CPU(U1), LPDDR and EMMC (U1901) might have problem.
- Please check power of EMMC, VCORE\_eMMC\_S(3.3V) and VDDIO\_HSMMMC (1.8V)

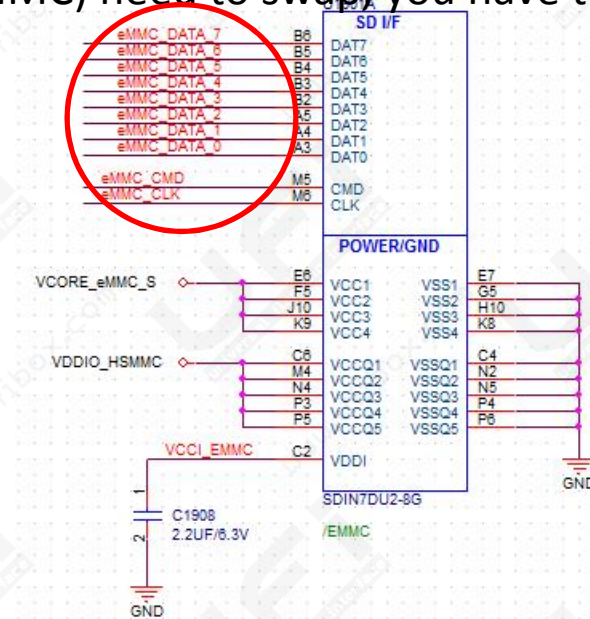
# Can not Power ON-5

- Please check signals of EMMC\_DATA\_0~7, EMMC\_CMD and EMMC\_CLK.
- If signals EMMC\_CMD and EMMC\_CLK are fine, then assuming CPU is ok.
- If signals EMMC\_DATA\_0~7 are fine, then assuming EMMC is ok.
- If all signals all fine, then swap LPDDR.
- Due to ZE500CL MP all use security CPU, It bundle with EMMC, therefore if any three of them (CPU, LPDDR and EMMC) need to swap, you have to swap three of them.

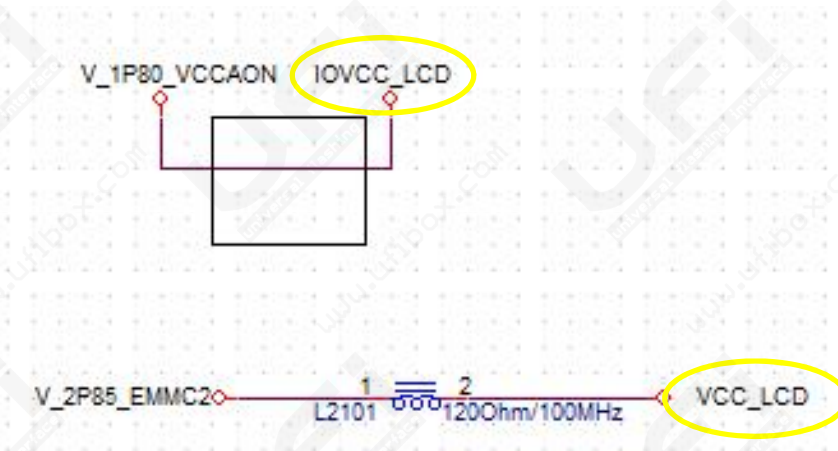
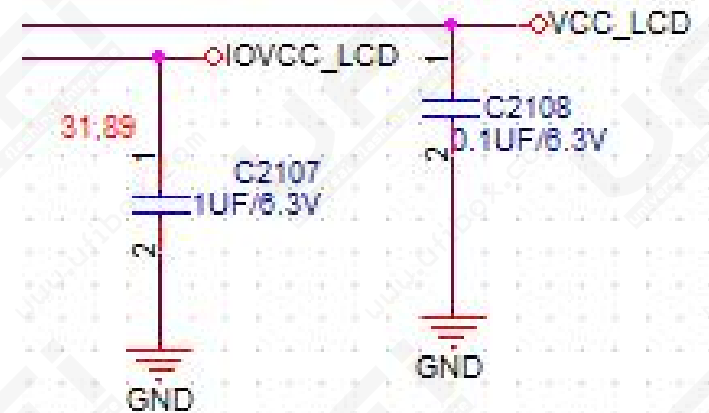
# LCM No Function-1

- Check LCM FPC assembly and CON2101 SMT solder status.
- Check if C2108.1 is 2.85V or C2107.1 is 1.8V or not.
- Check R2101~R2110 SMT solder status.

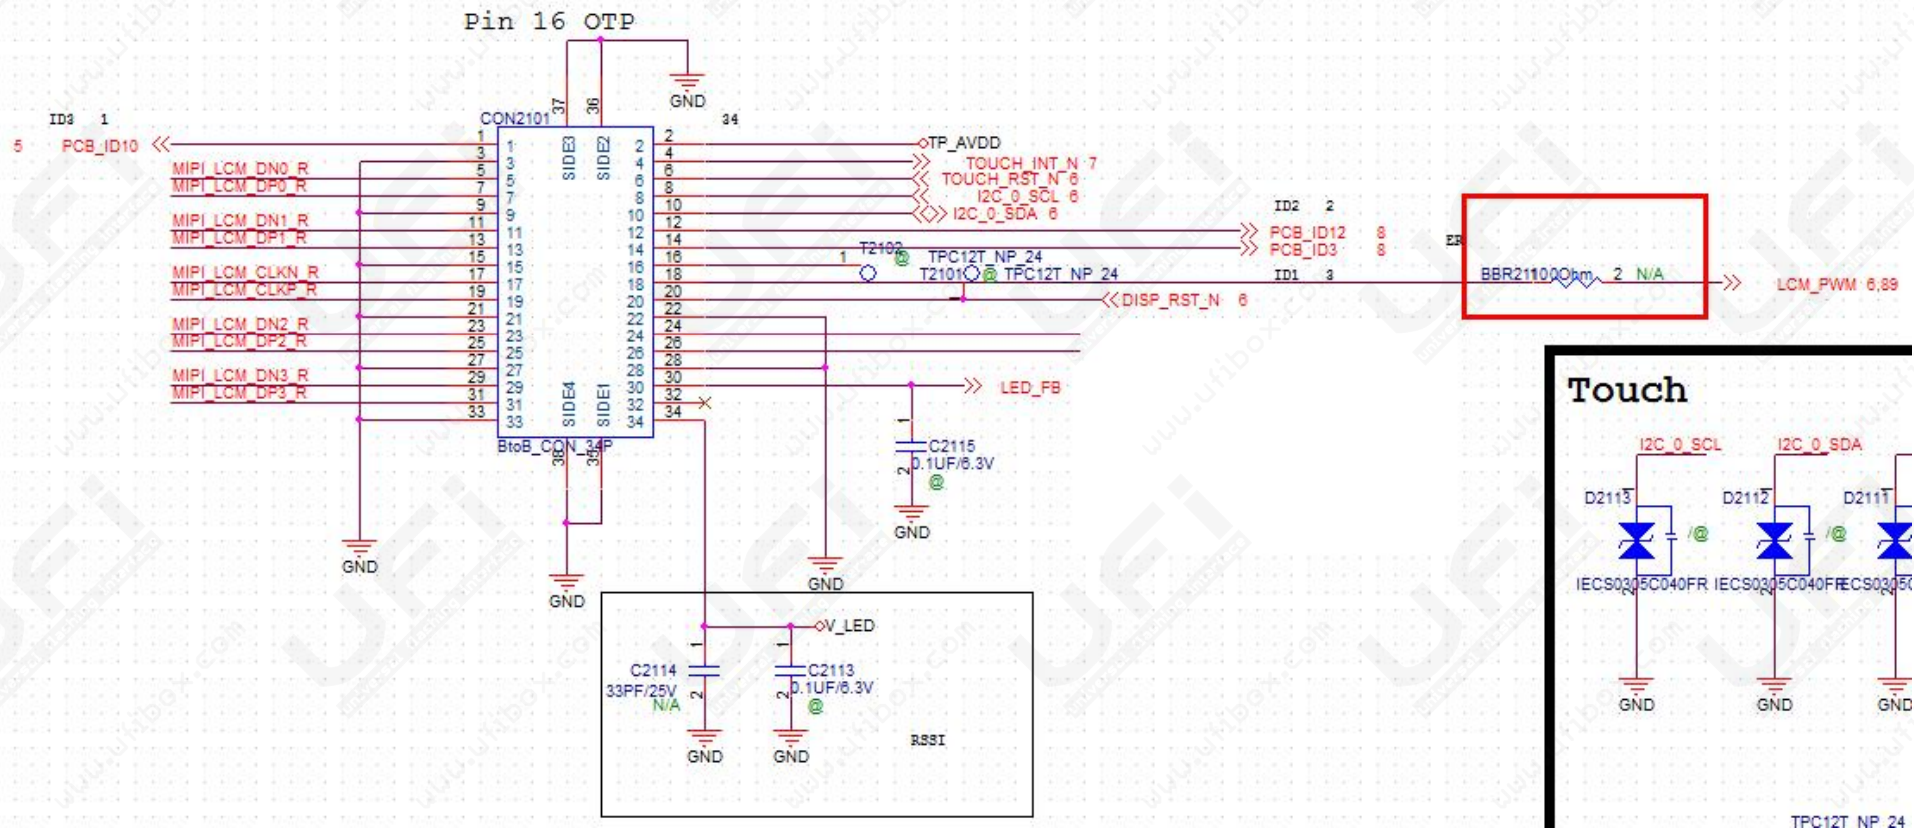
# LCM No Function-2

- Check MIPI\_LCM\_CLKP\_R, MIPI\_LCM\_CLKN\_R, MIPI\_LCM\_DP(0:3)\_R and MIPI\_LCM\_DN(0:3)\_R Signal.

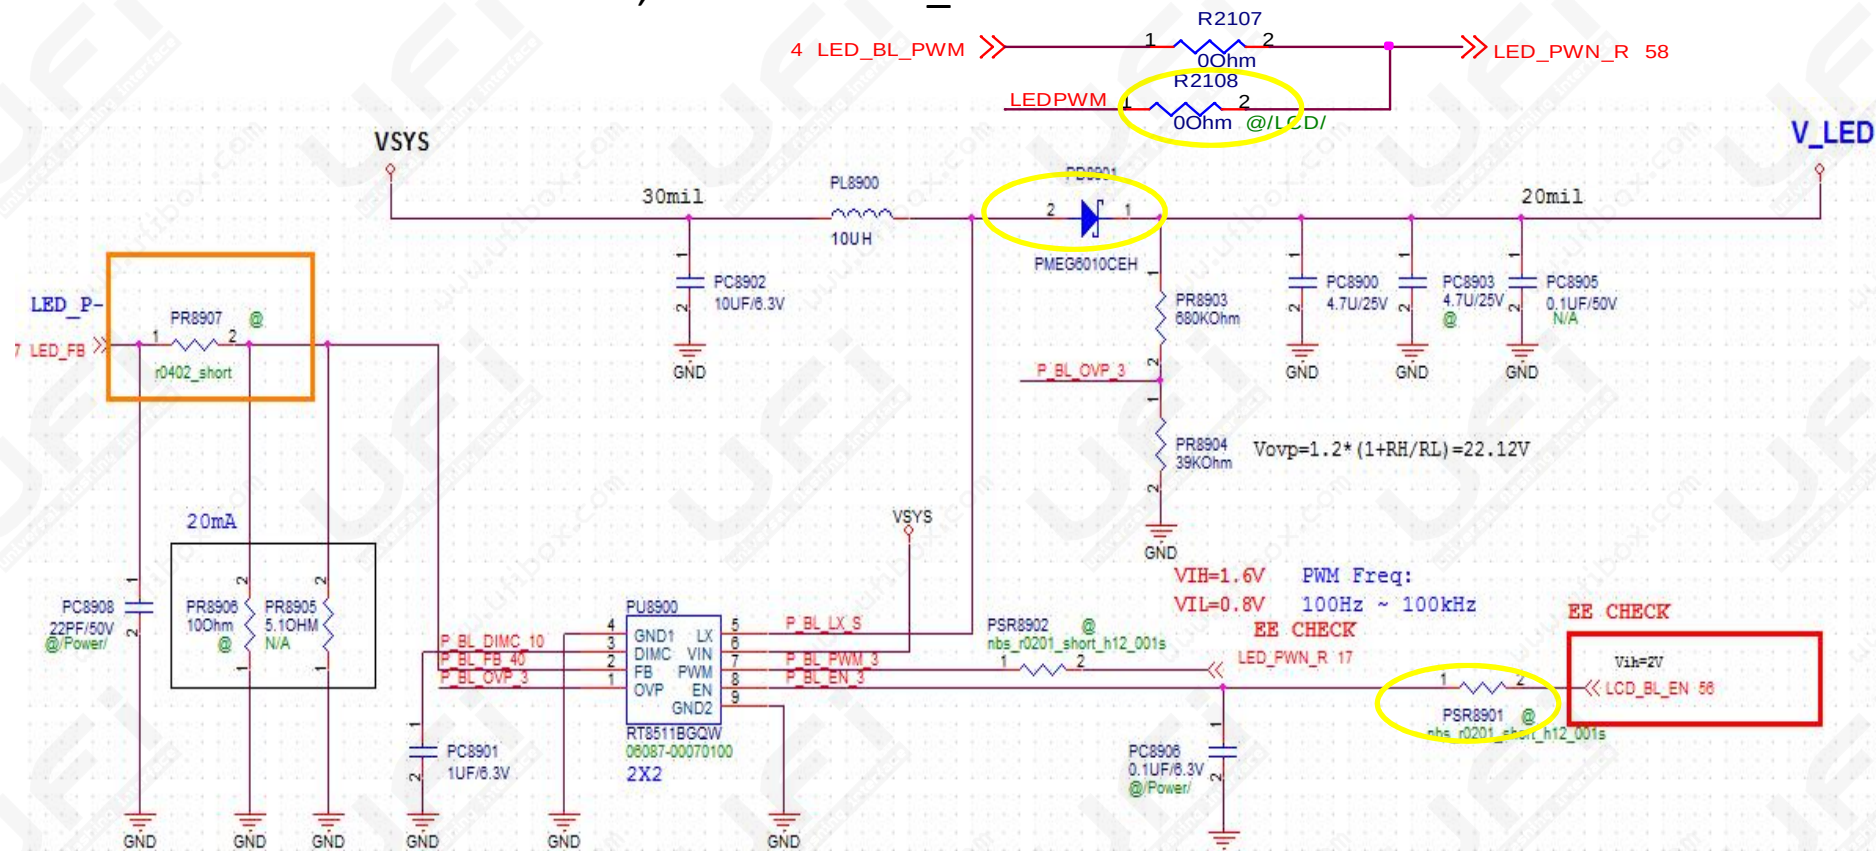
# Backlight No Function

- Check LCM FPC assembly and CON2101 SMT solder status.
- Check PU8900 R2108 and PD8901 SMT polar and solder status.
- Check PC8906.1 is 3.3V, if not change PMIC(PU8401).
- Check BBR2110 SMT status.
- Check PD8901.2 is VSYS, PD8901.1 is V\_LED.

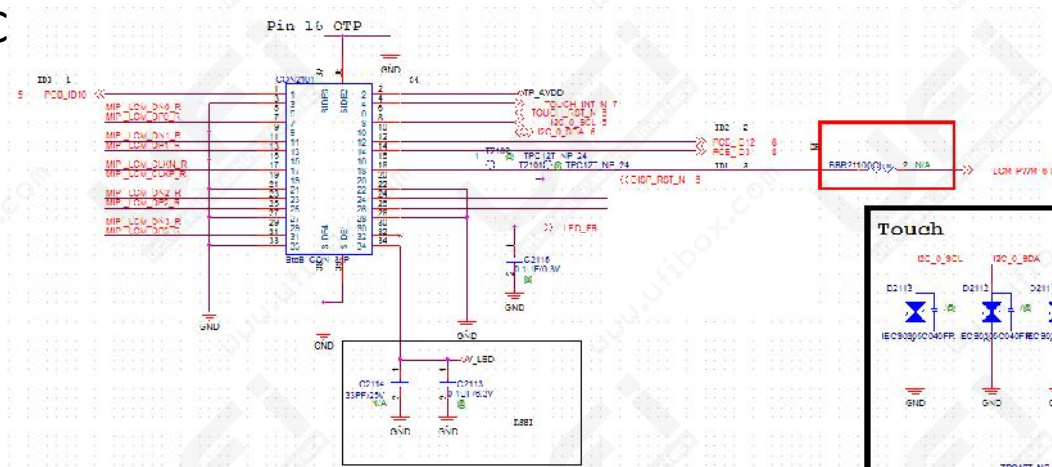
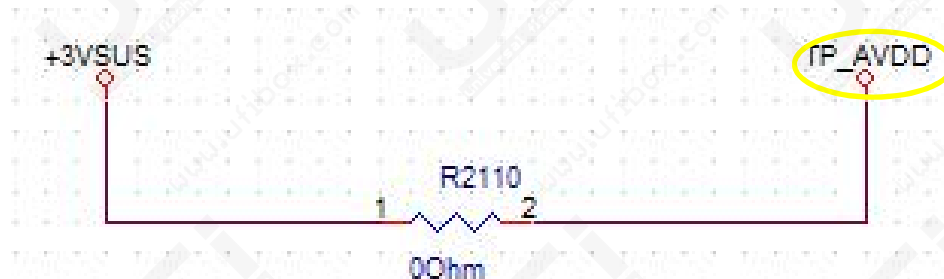
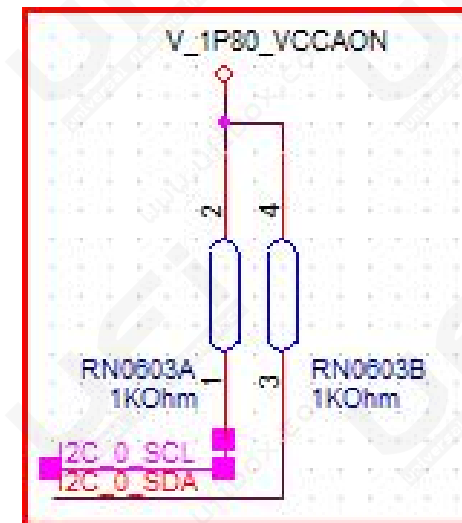
# Touch No Function

- Check TP assembly, LCM FPC, and CON2101 SMT solder status.
- Check if R2110.2 is 3.3V or not.
- C

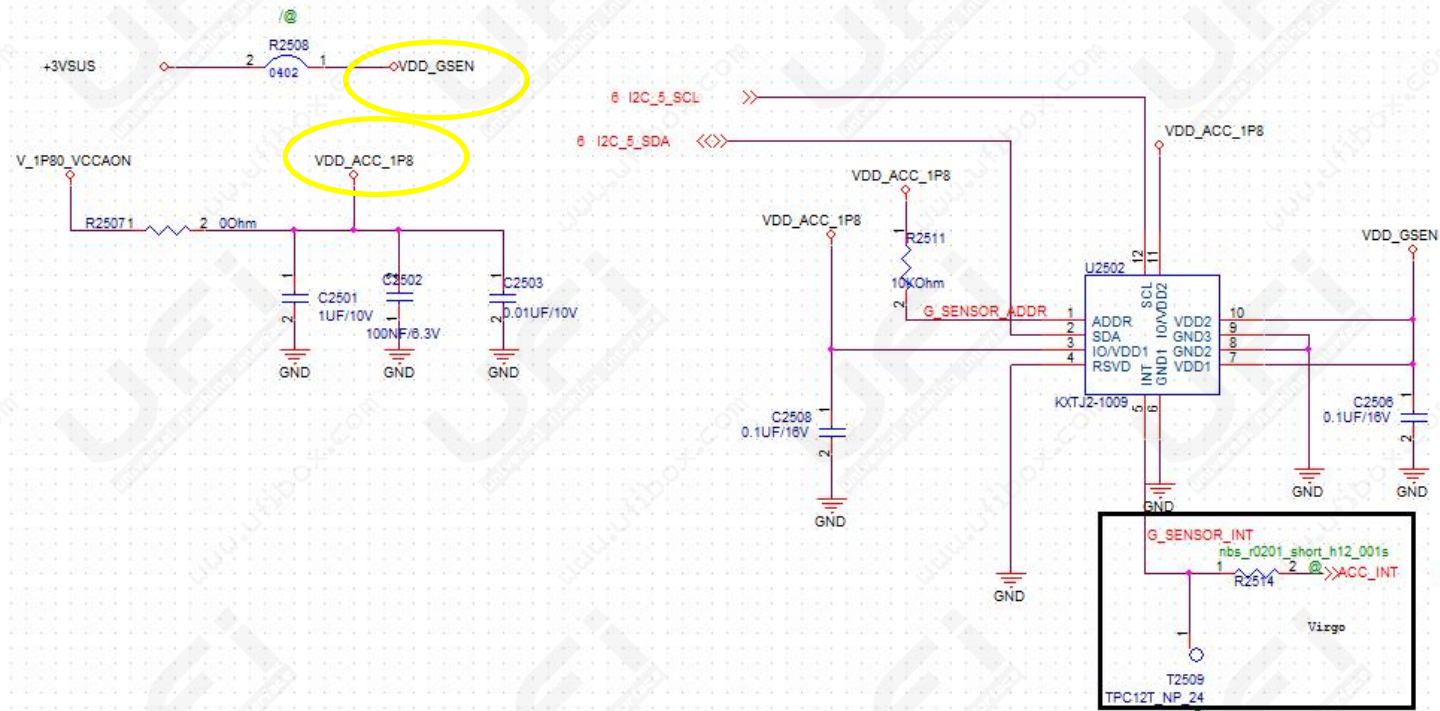
# G-Sensor No Function

- Check G-sensor IC(U2502) SMT polar and solder status.
- Check if C2501.1 is 1.8V or R2508.1 is 3.3V or not.
- Check I2C\_5\_SDA and I2C\_5\_SCL is 1.8V and SDA/SCL signal.
- If above are all normal, change U2502 to verify.

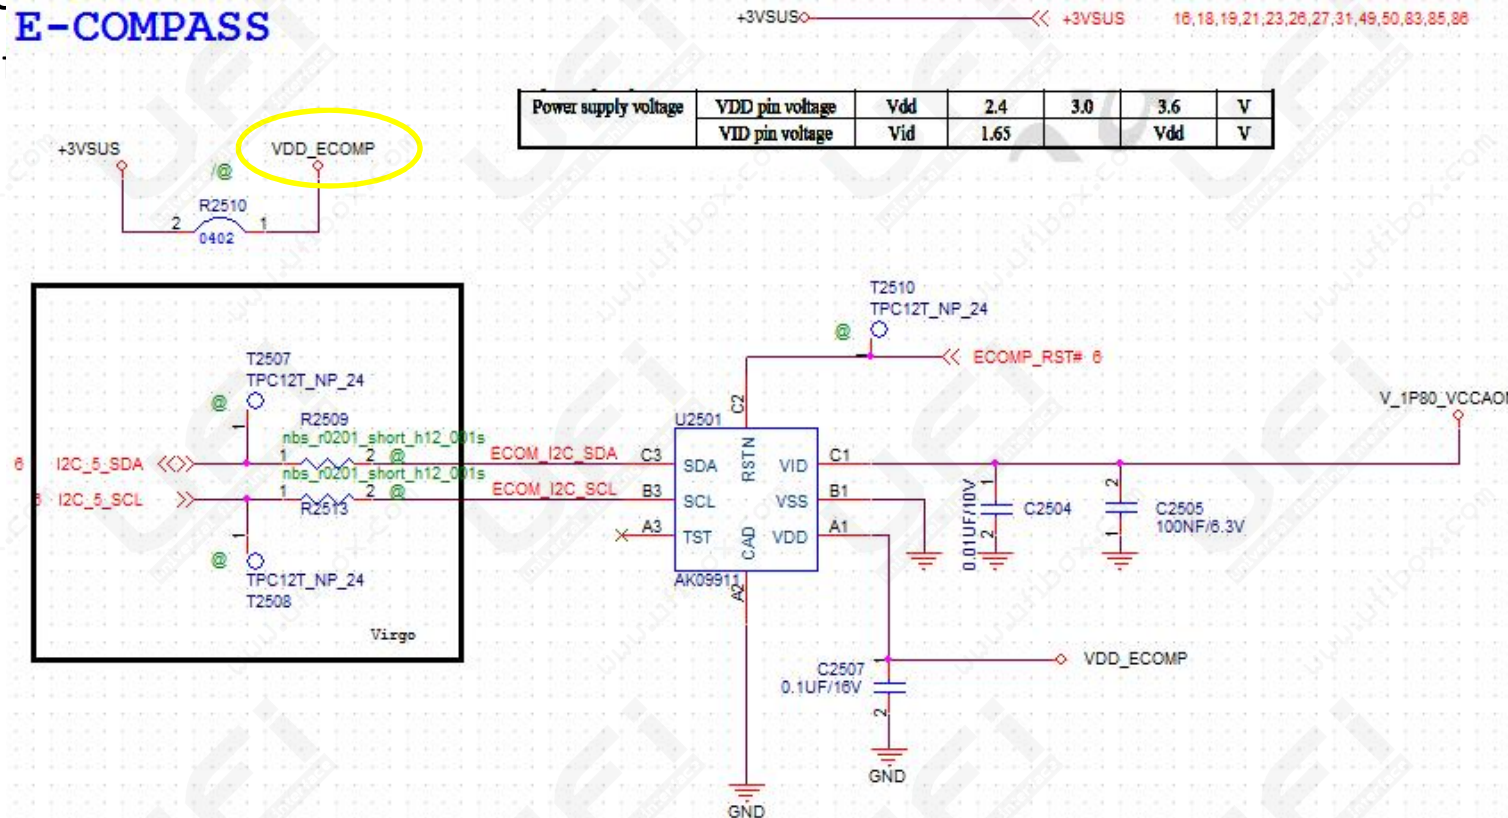
# E-Compass No Function

- Check E-Compass IC(U2501) SMT polar and solder status.
- Check if C2507.1 is 3.3V or C2505.2 is 1.8V or not.
- Check I2C 5 SDA and I2C 5 SCL is 1.8V and SDA/SCL signal

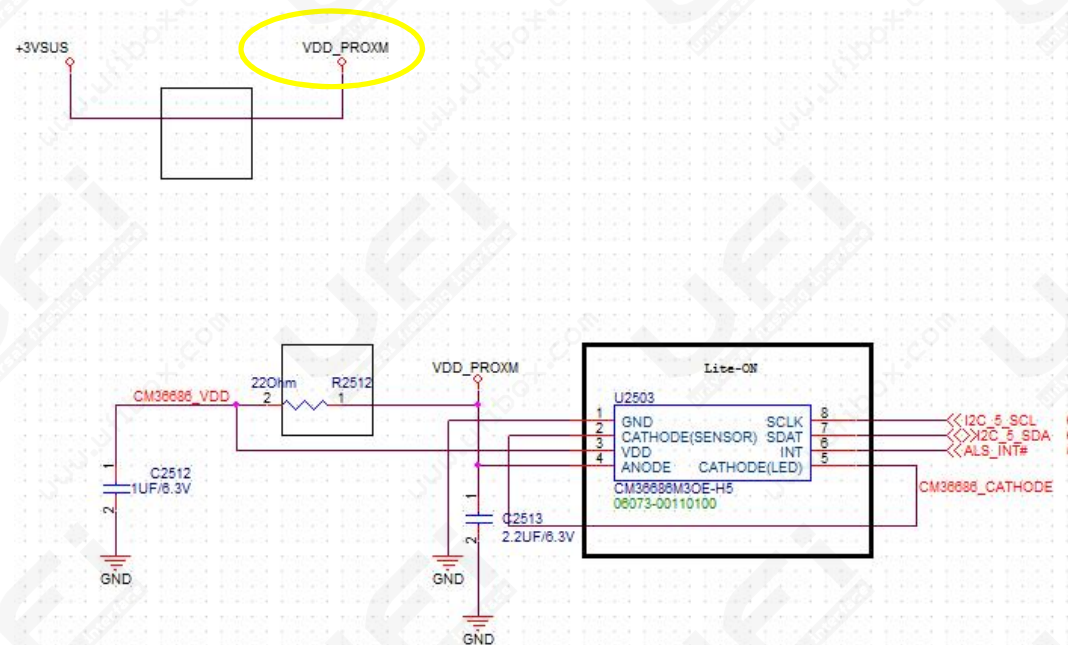
# Proximity / Light Sensor No Function

- Check Proximity/Light sensor IC(U2503) SMT polar and solder status.
- Check if C2513.1 is 3.3V or not.
- Check I2C\_5\_SDA and I2C\_5\_SCL is 1.8V and SDA/SCL signal.
- If above are all normal, change U2503 to verify.

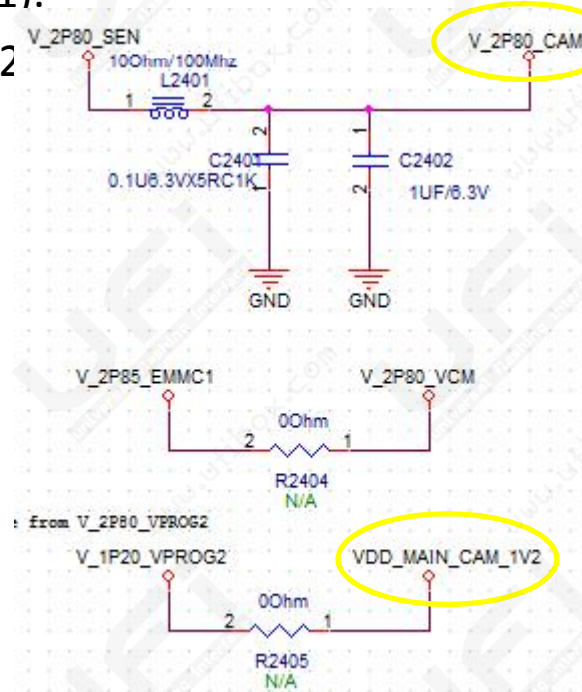
# 8M Camera No Function

- Check 8M assembly or change new 8M Camera module to verify again.
- Check CON2401 SMT solder status.
- Check Filter L2402~L2406 SMT solder status.
- Check C2402.1 is 2.8V, if not change PMIC(PU8401) and C2411.1 is 1.2V, if not check LDO(PU9421).
- Check I2C\_4\_SDA and I2C\_4\_SCL signal.

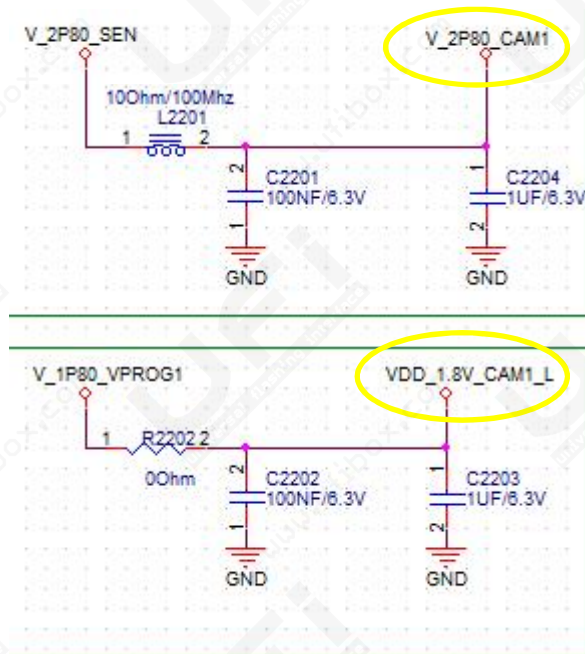
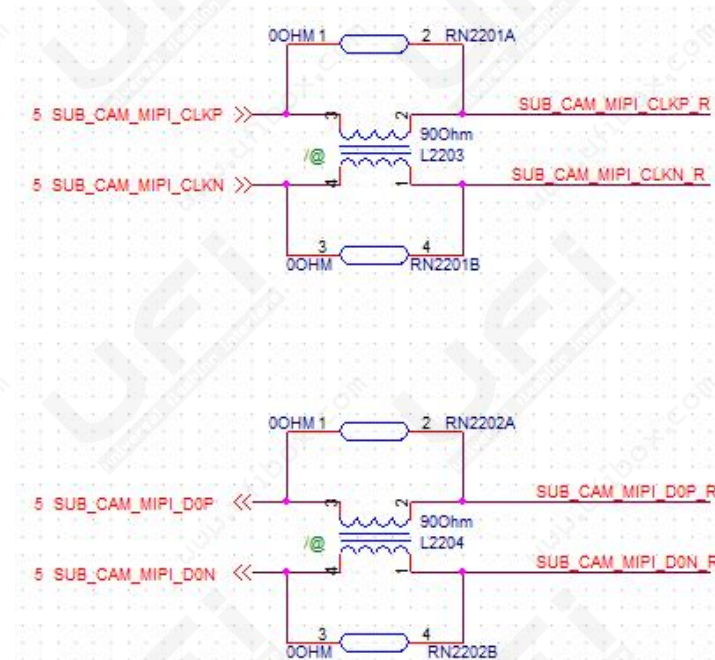
# 2M Camera No Function

- Check 2M assembly or change new 2M Camera module to verify again.
- Check CON2201 SMT solder status.
- Check RN2201 and RN2202 SMT solder status.
- Check C2203.1 is 1.8V, if not change PMIC(PU8401) and C2204.1 is 2.8V, if not check LDO(PU9421) .
- Check I2C\_4\_SDA and I2C\_4\_SCL is 1.8V and SDA/SCL signal.

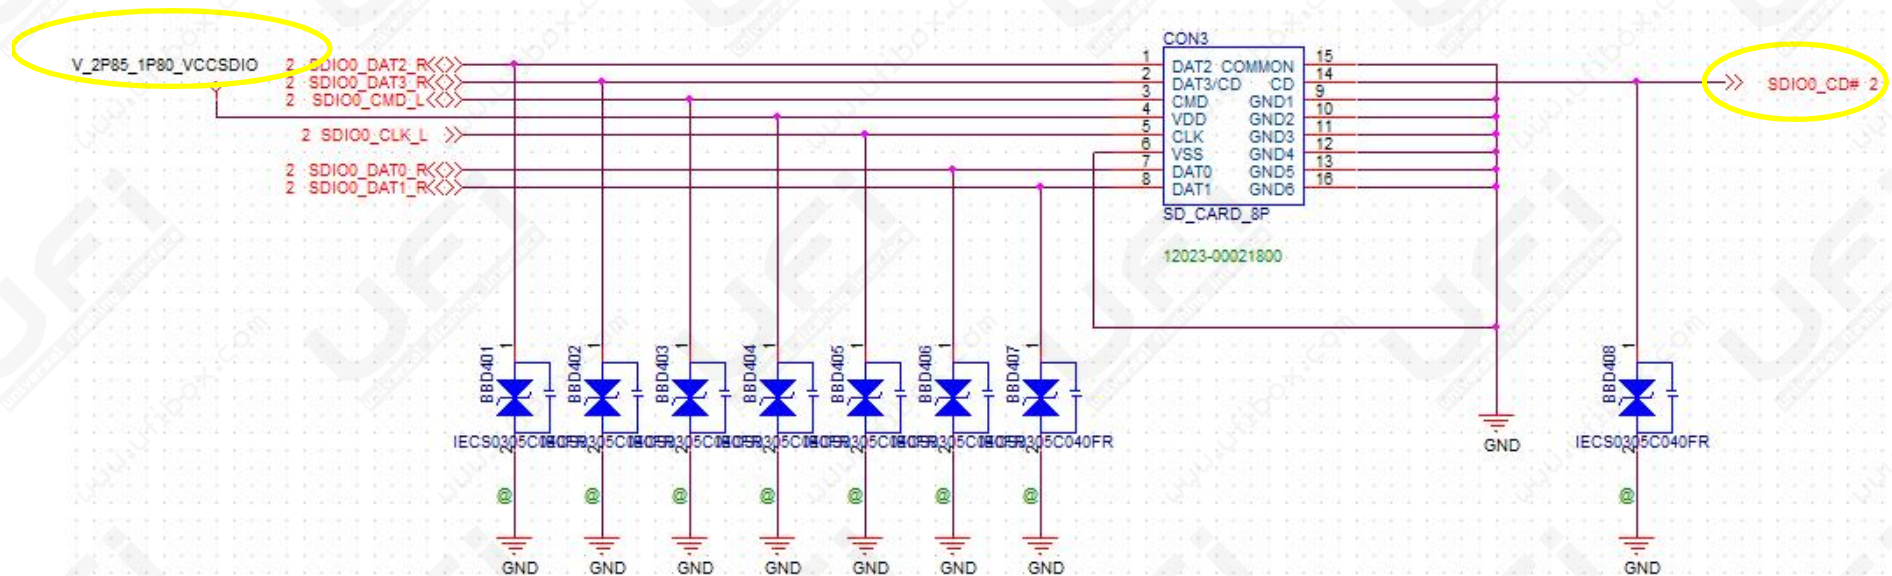
# SD Card No Function( IOFPC )

- Verify the problem is occurred on M/B or IOFPC.
- Check CON3 Connector SMT solder status.
- Check V\_2P85\_1P80\_VCCSDIO voltage is 2.85V, if not 2.85V change PMIC(PU8401).
- Check SDIO0\_CD# whether Low signal when SD card insert.
- Check SDIO0\_DAT(0:3)\_R, SDIO0\_CMD\_L and SDIO0\_CLK\_L signal.

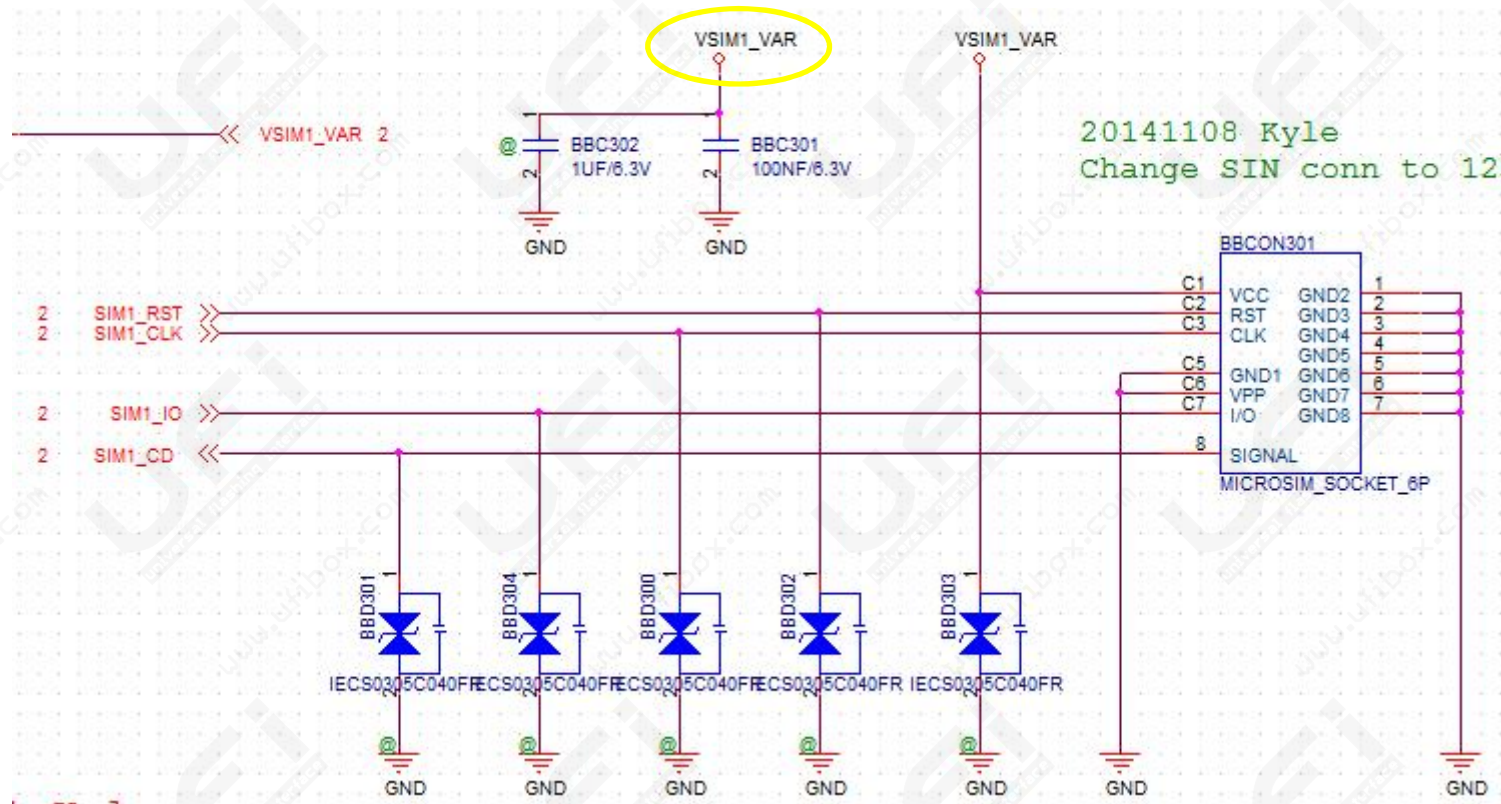
# SIM No Function( IOFPC )

- Verify the problem is occurred on M/B or IOFPC.
- Check BBCON401 Connector SMT solder status.
- Check BBR5302.1(VSD2\_1V8) is 1.8V, if not check BBL5302 SMT status or Change Modem IC(U5101).
- Check BBR302.1 is 1.8V, BBD301.1 is 1.8V when SIM Card plug in.

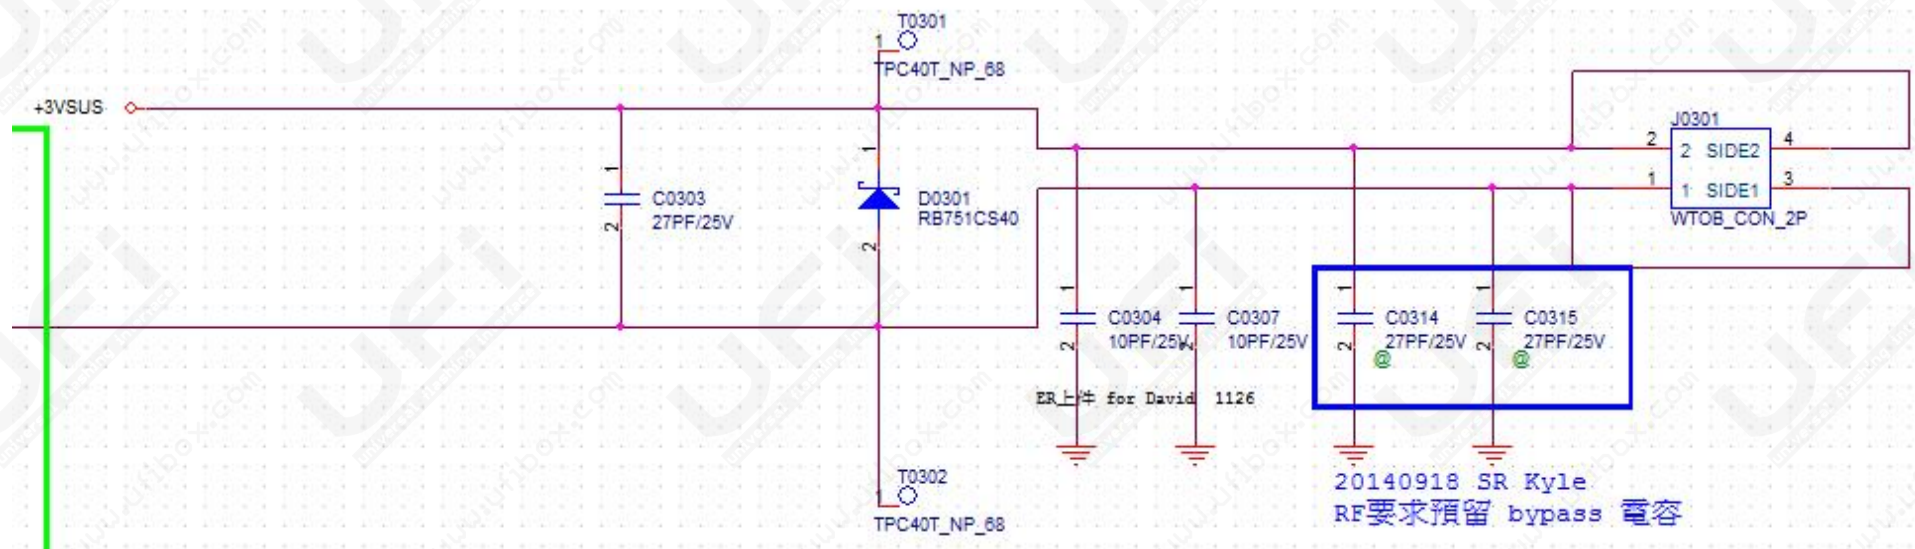
# Vibrator No Function( S/B )

- Verify the problem is occurred on M/B, IOFPC or S/B.
- Check J0301 Connector SMT solder status.
- Check C0304.1 voltage whether 3.3V or not, if not, check R1702 component or solder status.
- Check VIBE\_PWM\_VB whether Low signal when Vib motion.

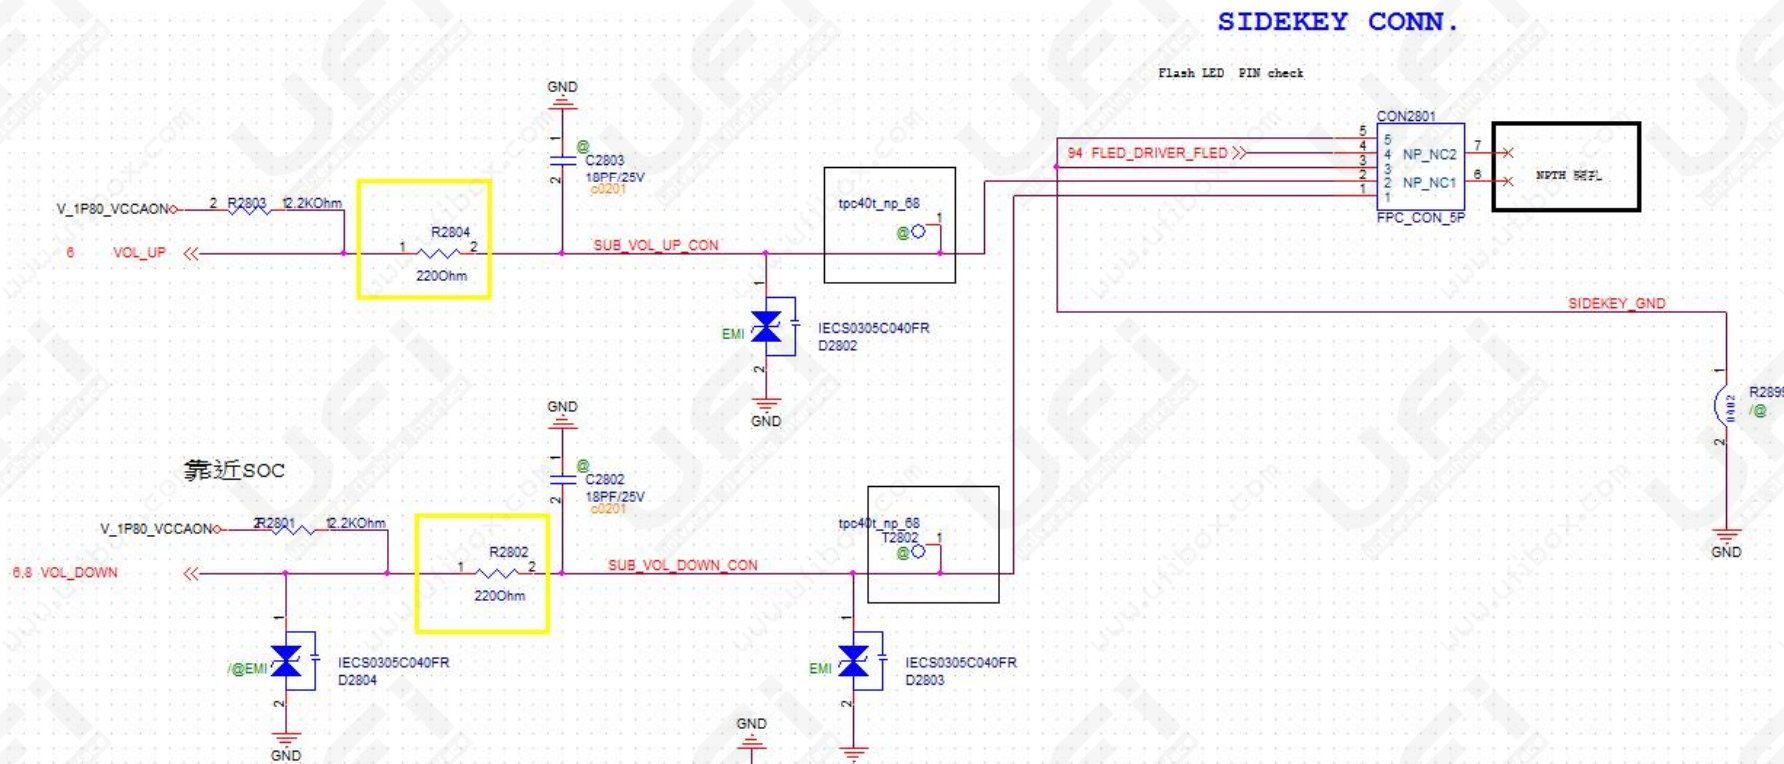
# VOL Key No Function( VOLFPC )

- Verify the problem is occurred on M/B or VOLFPC
- Check CON2801 Connector SMT solder status.
- When press Vol Up key, check R2804.1(VOL\_UP) is Low and D2802 whether short.
- When press Vol Down key, check R2802.1(VOL\_DOWN) is Low and D2803 whether short.

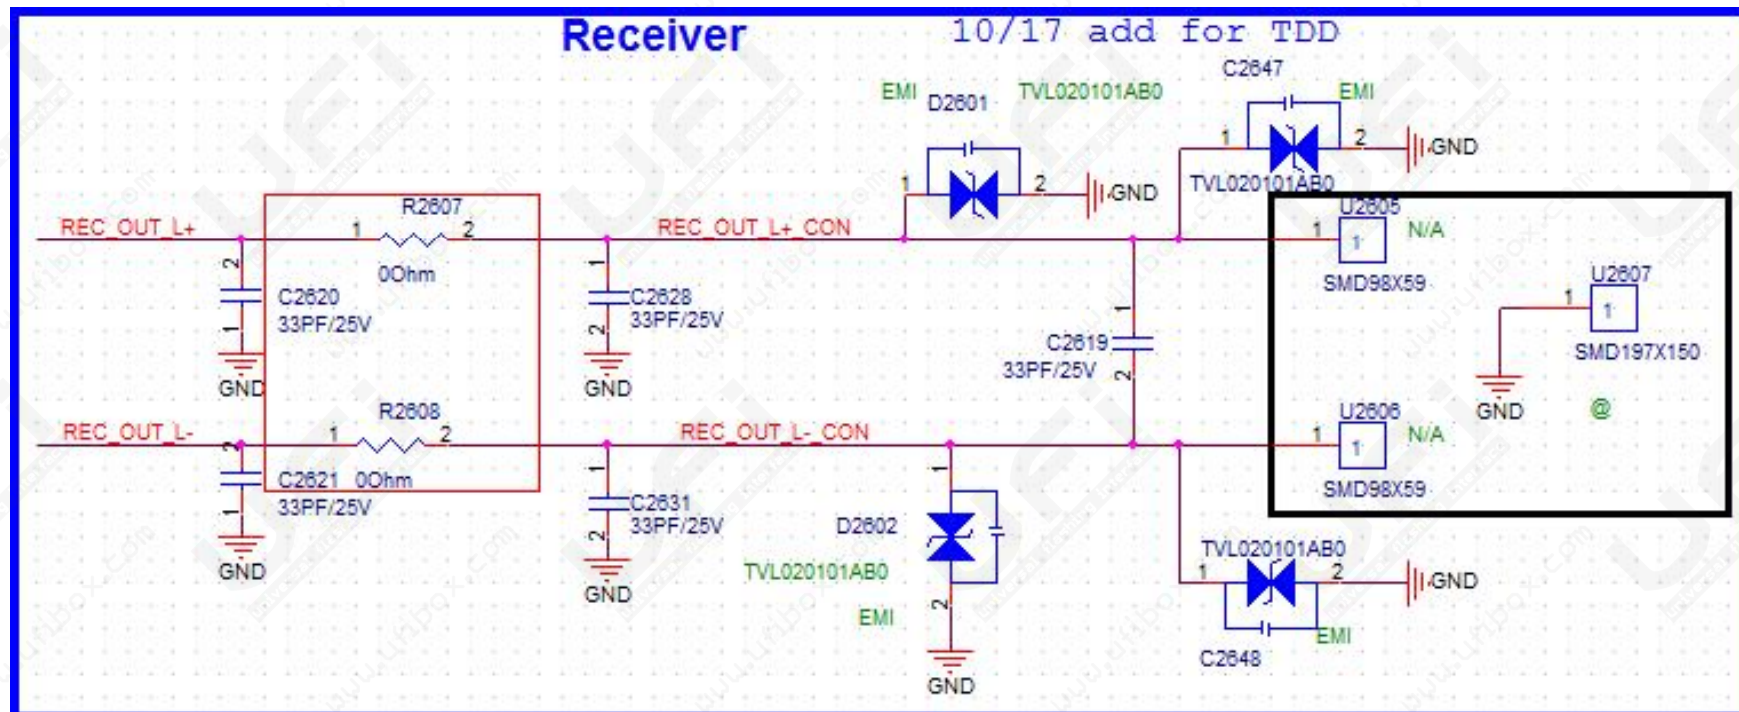
# Receiver No Function

- Check Receiver component contact MB status or change new Receiver to verify.
- Check R2606 and R2607 SMT solder status.
