# ZE500CL(Virgo) EE

## Trouble Shooting Guide

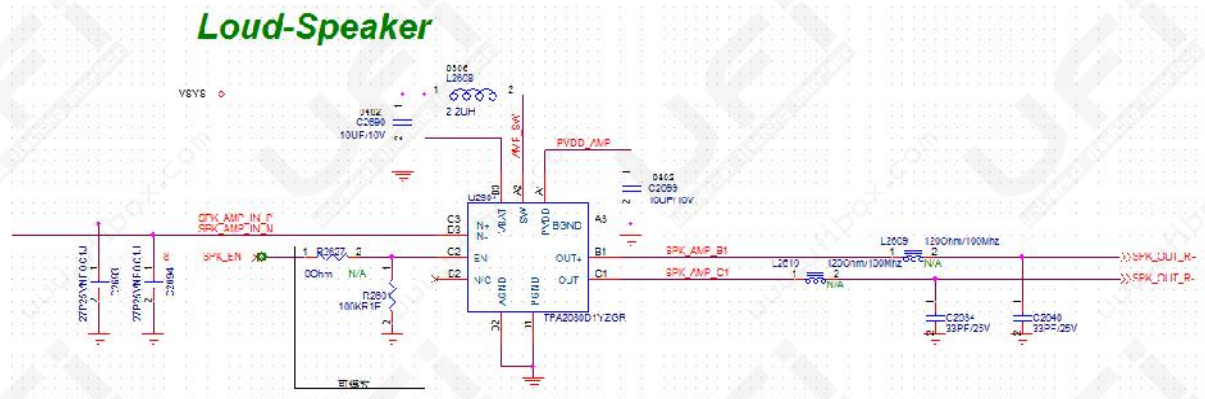
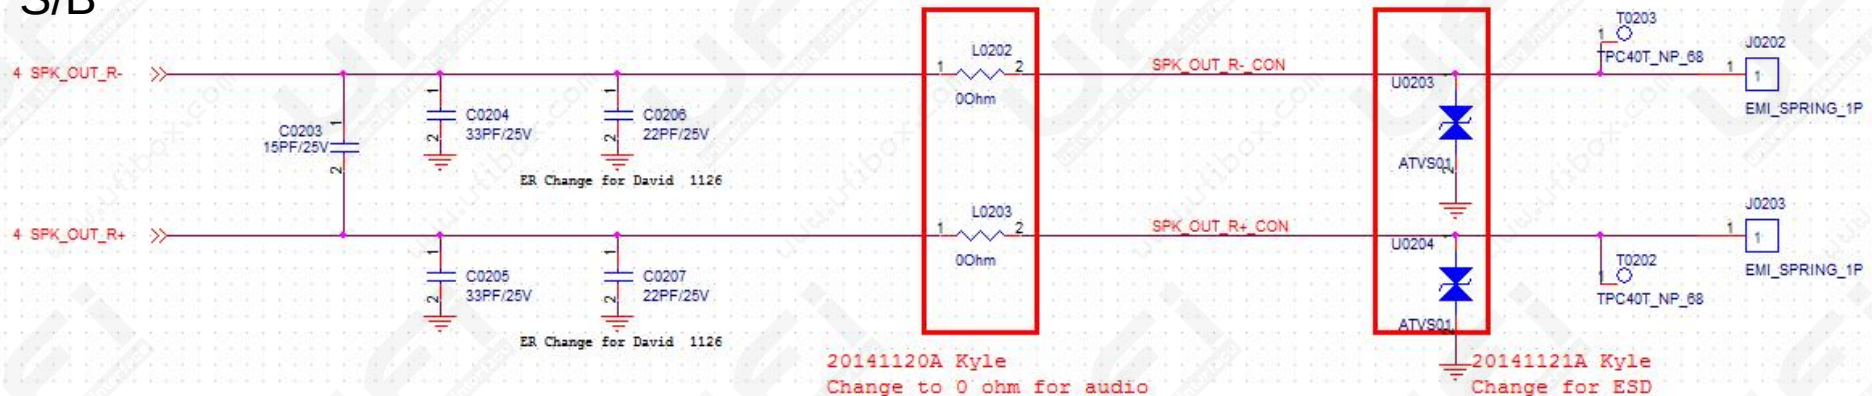
# Speaker No Function( S/B )

- Verify the problem has occurred on M/B, or FPC or S/B
- Check Speaker component contact S/B status or change new Speaker to verify.
- Check U2604 SMT polar and solder status.
- Check C2692, C2700, L2609, L2610, **L0202 and L0203** SMT solder status.

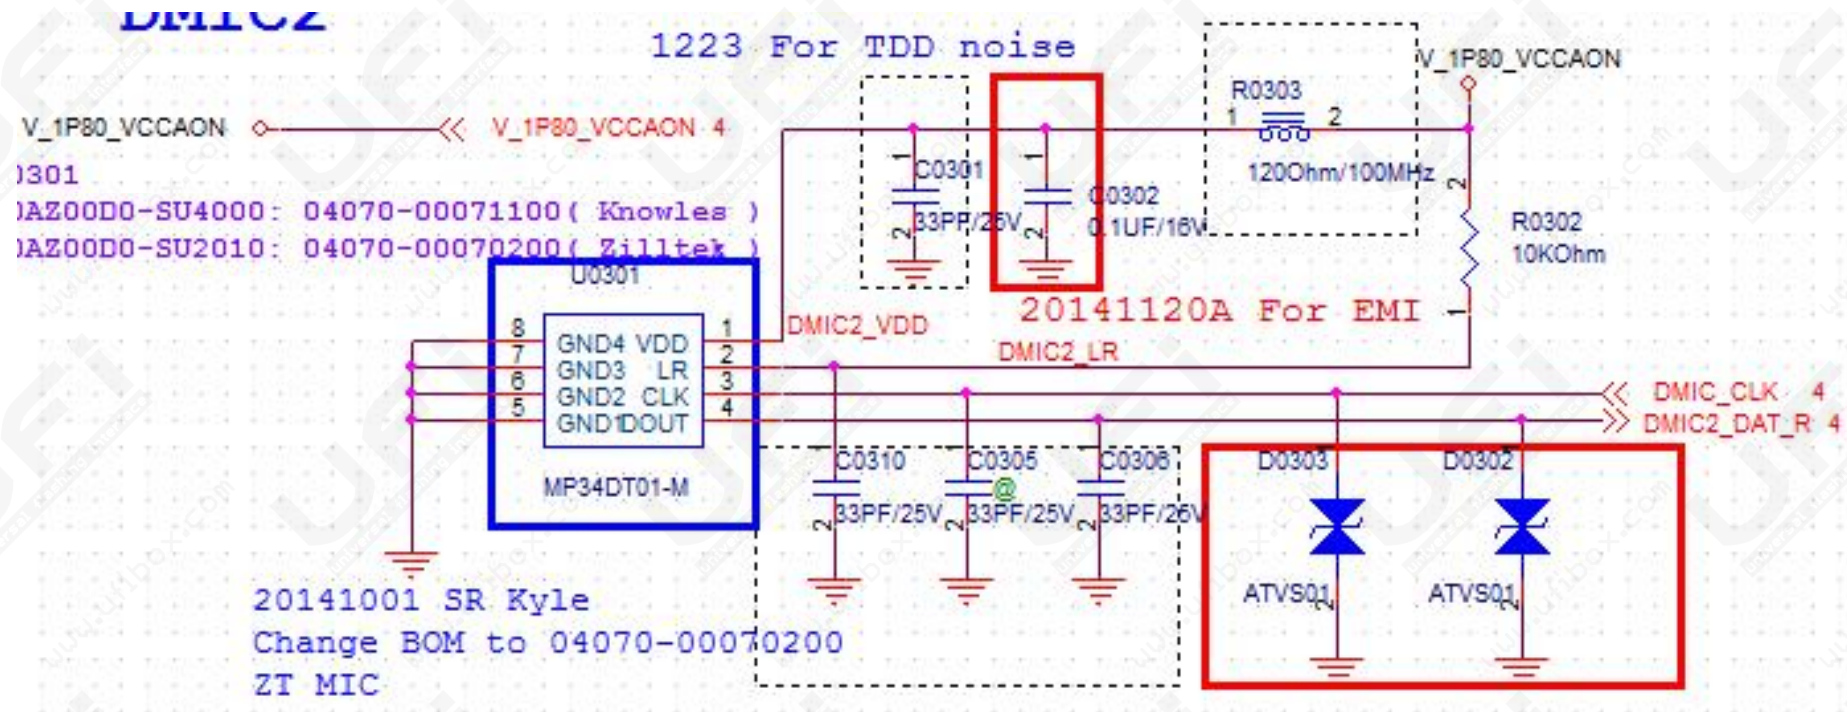
# Main Mic No Function( S/B )

- Verify the problem is occurred on M/B, IOFPC or S/B.
- Check U0301 SMT polar and solder status.
- Check C0302.1 is 1.8V and check DMIC\_CLK and DMIC2\_DAT\_R signal.

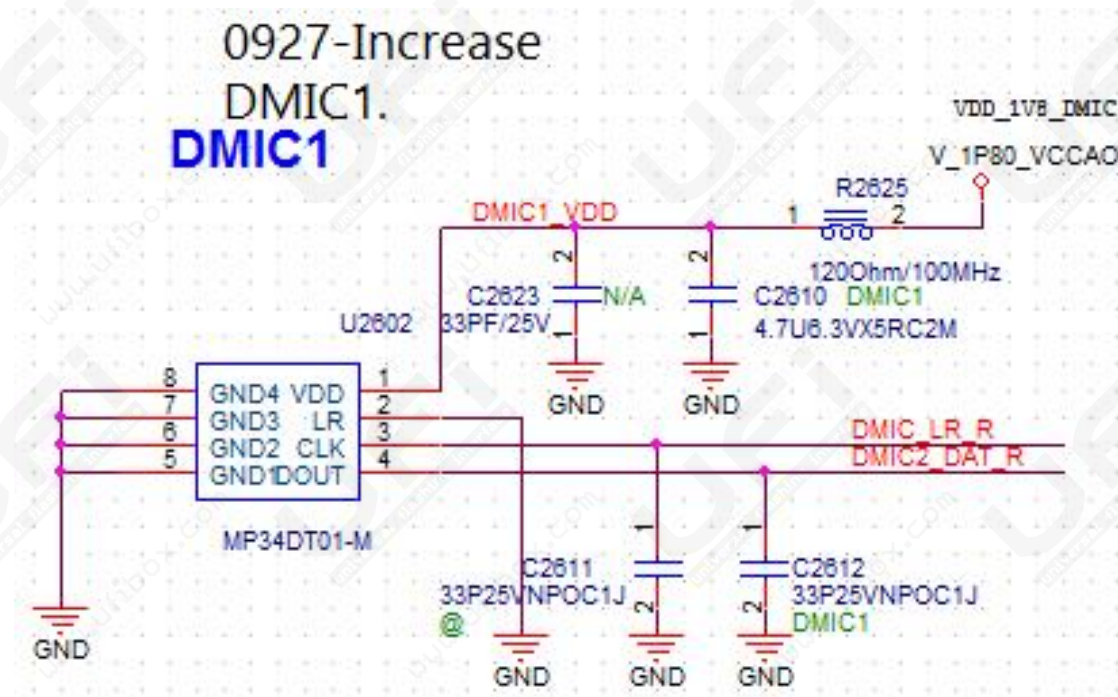
## 2nd Mic No Function( M/B )

- Check U2602 SMT polar and solder status.
- Check C2610.1 is 1.8V and check DMIC\_LR\_R and DMIC2\_DAT\_R signal.

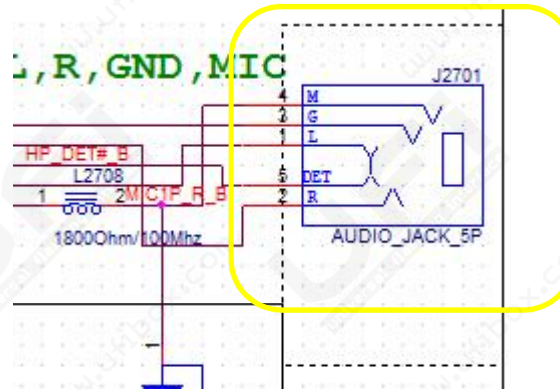
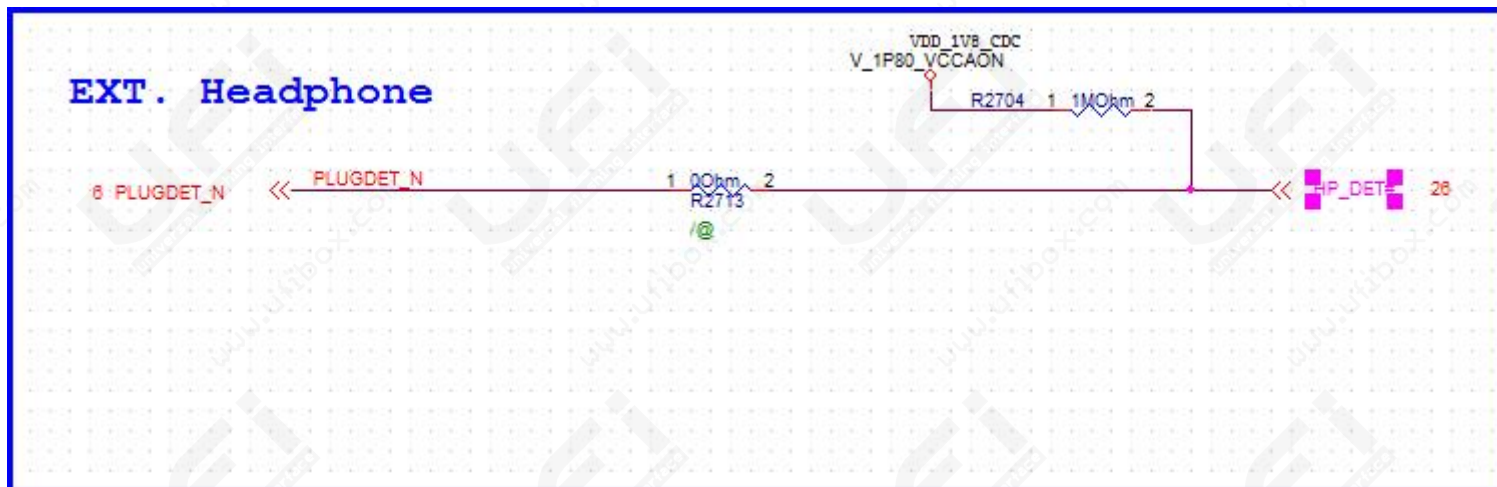
# Headset No Function - 1

- Check J2701 SMT solder status and L2707 SMT solder status.
- Check C2646.1 is Low when plug in Headset, if not, check R2615, R2704, L2707 SMT status.

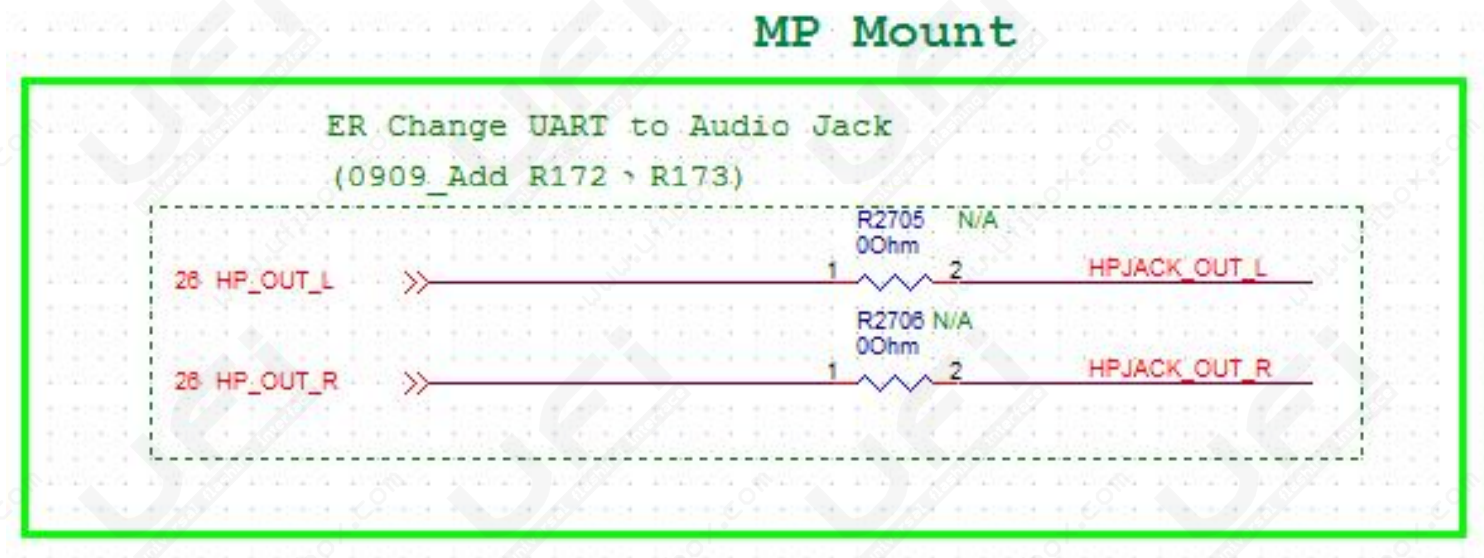
# Headset No Function – 2 (L/R)

- Check headset R and L route components, include R2705~R2708 and L2703, L2704, L2706 and L2709 SMT solder status.

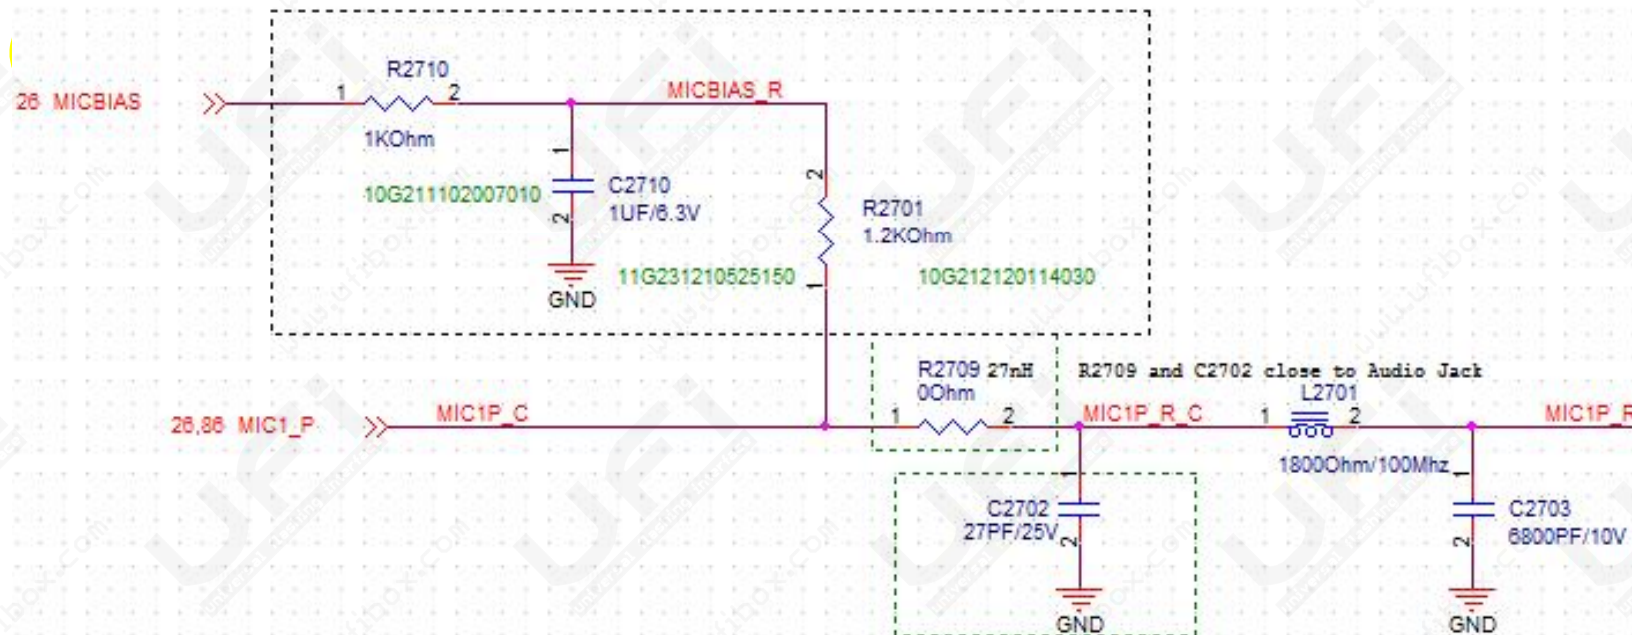
# Headset No Function – 3 (Mic)

- Check MICBIAS R2710.1 is 2.95V or not, if not check U2601.
- Check MIC1P\_C is like normal M/B when plug in Headset.

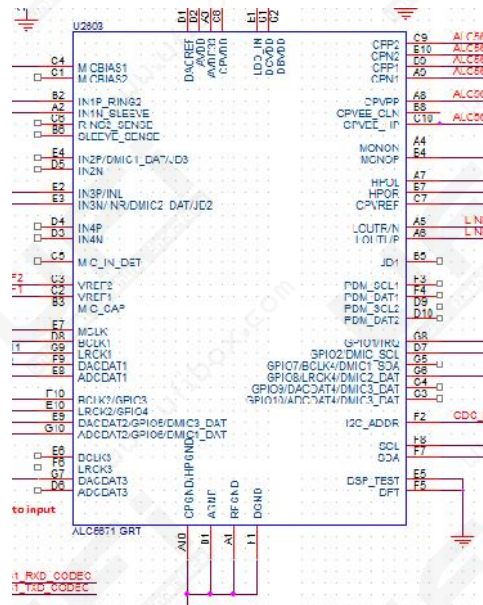
# Check Audio Codec

- Check polarity and x-ray of audio codec U2603.
- Check I2C\_1\_SCL and I2C\_1\_SDA of audio codec.
- Check power of audio codec.
- If recording fail, please check CLV\_I2S3\_CLK, CLV\_I2S3\_FS, CLV\_I2S3\_RXD, OSC\_CLK\_OUT\_0 and DACREF\_CDC. If signals ok, swap CPU.
- If playback fail, please check CLV\_I2S3\_CLK, CLV\_I2S3\_FS, CLV\_I2S3\_TXD, OSC\_CLK\_OUT\_0 and DACREF\_CDC. If signals ok, swap audio codec.

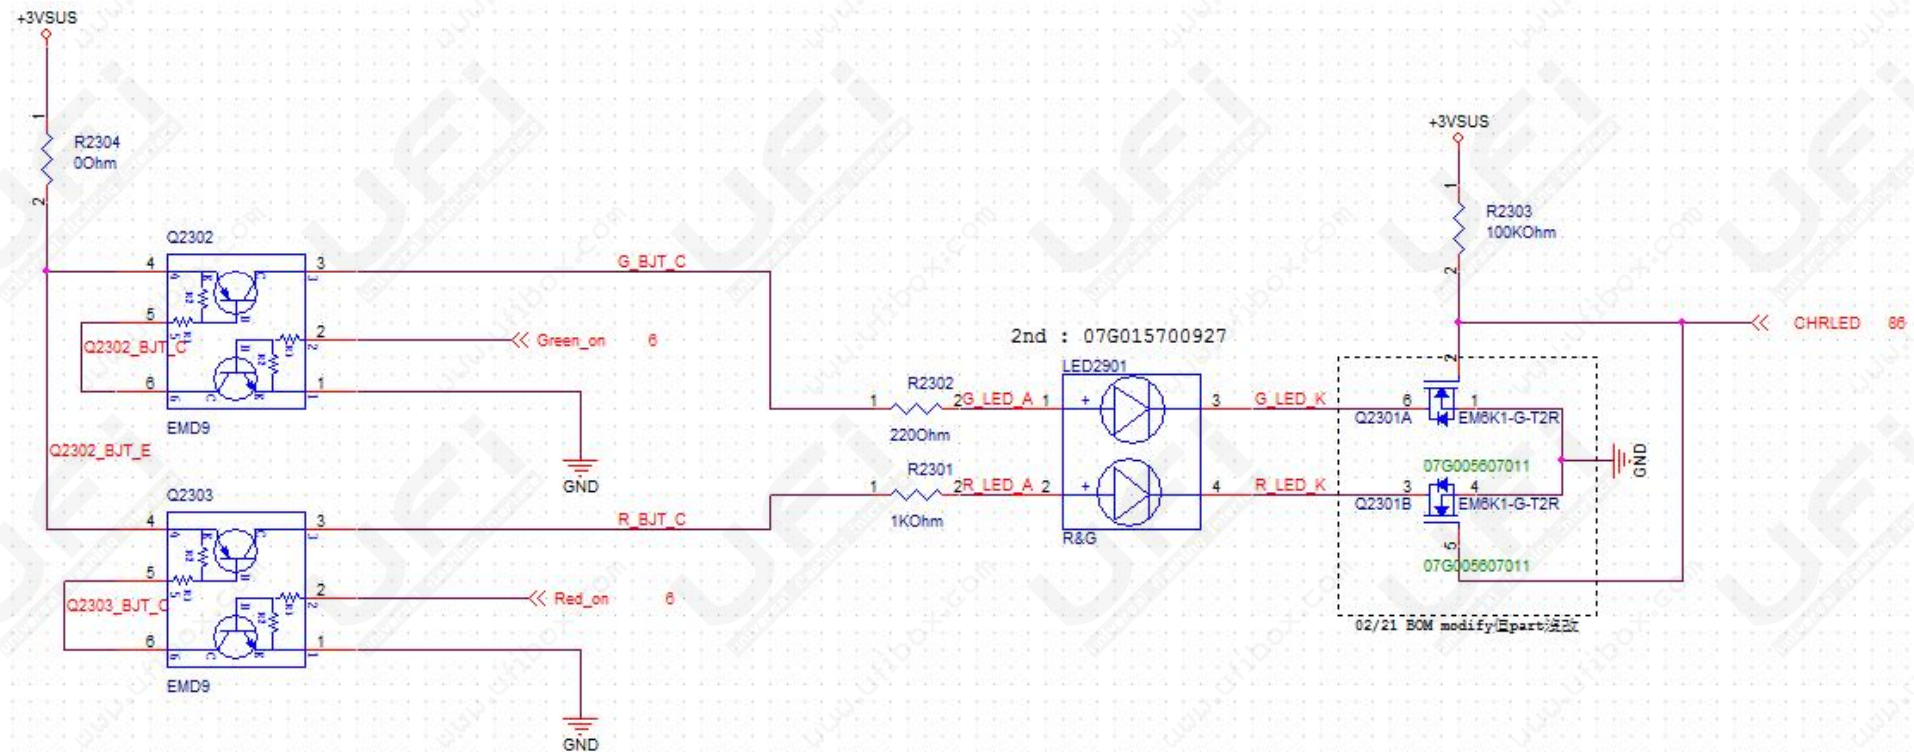
# Charger LED No Function

- Check LEDZ901, Q2302 and Q2303 SMT polar and solder status.

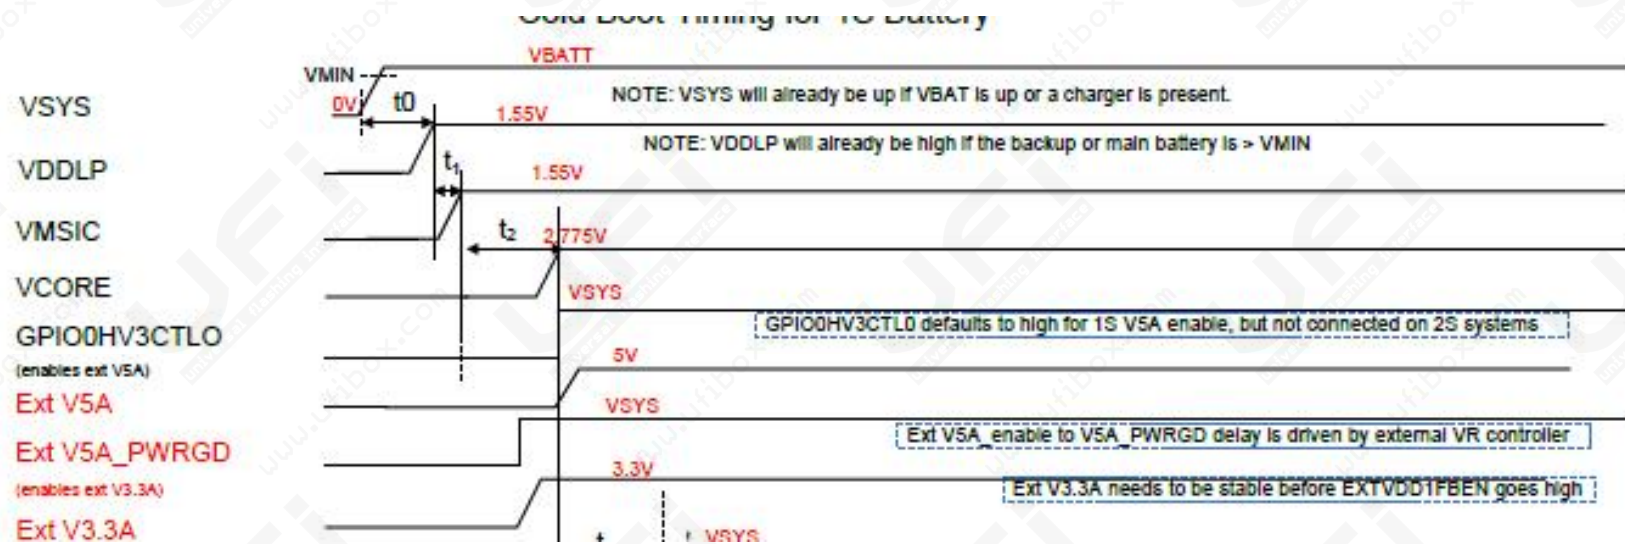
若卡在 **+3VSUS**沒起來且短路到地，請依照  
power sequence 確認其他的電壓並確認用到  
此電壓的電路
