One Touch 282(A)

MTC 268

RPFRG1801

L2 Repair Document

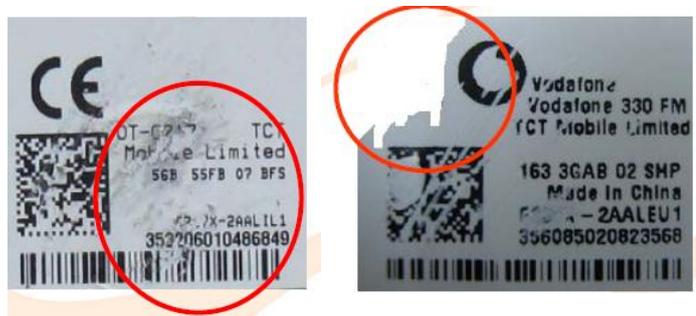
1) IMEI sticker check:

- a) The IMEI number MUST be the same with the one on the IMEI sticker. If not, it's out of warranty policy
- b) IMEI label should not be
 - Removed
 - Scratched
 - Unreadable
 - Un-approved or un-provided by Alcatel.

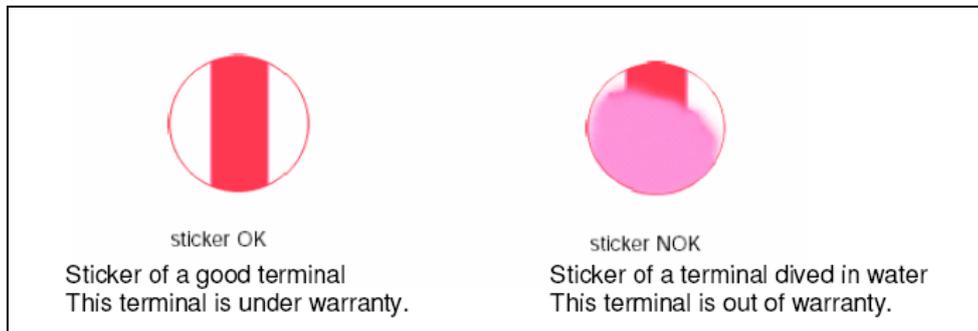
2) Humidity sticker: Liquid detection on humidity sticker.

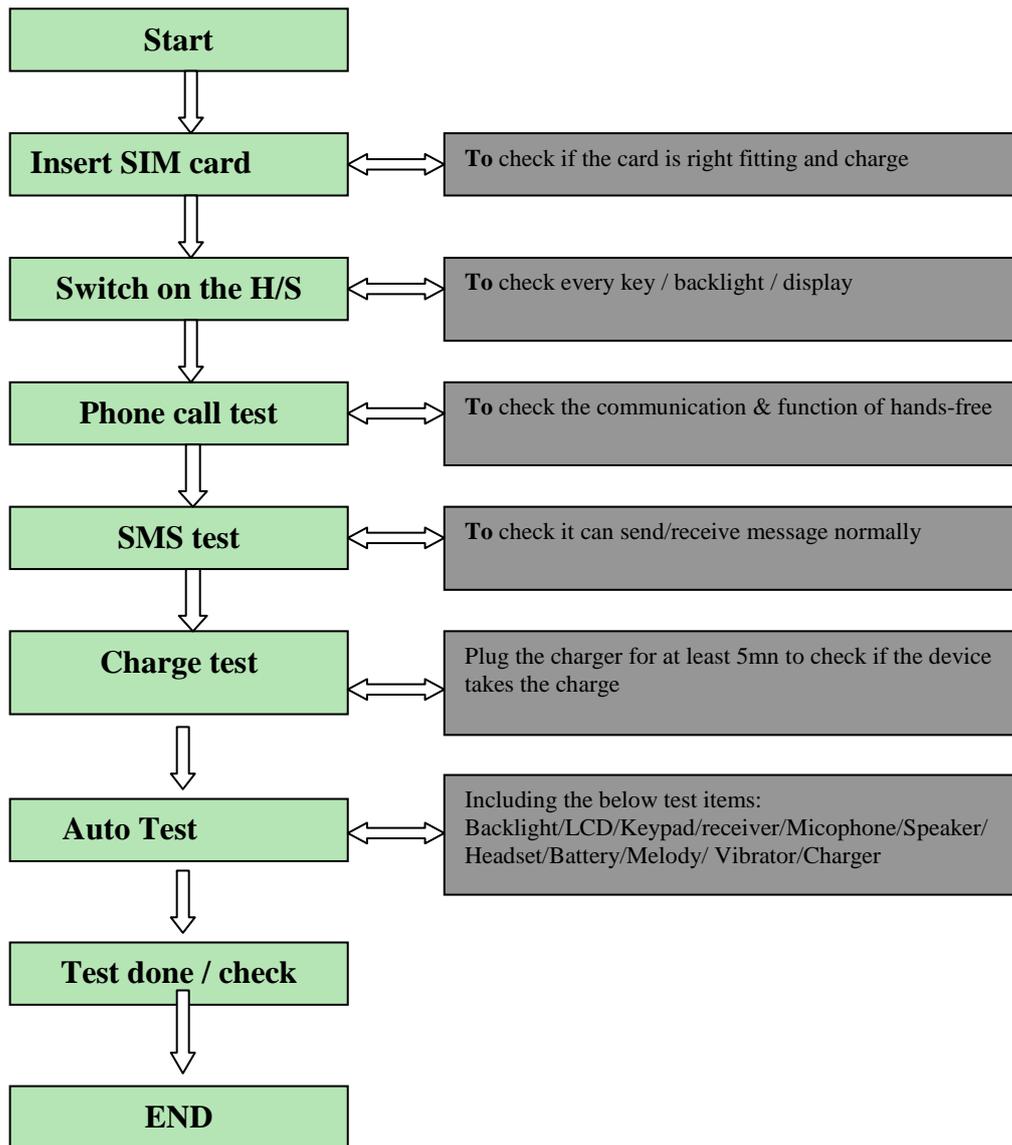
- 1) Check that the SIM card is set correctly.
- 2) Insert the battery.
- 3) Power on the cell phone.
- 4) If the cell phone can not power on, visually check the condition of the battery connector. Replace it if necessary.
- 5) If the cell phone asks to input NCK code, which means it is SIM locked, and can only be worked with dedicated SIM card. Use the correct SIM card.
- 6) Enter the phone code if necessary.
- 7) If power on, test step by step with the auto test code:

Press *#2886# in dial screen and select "OK" or "START" to begin the testing

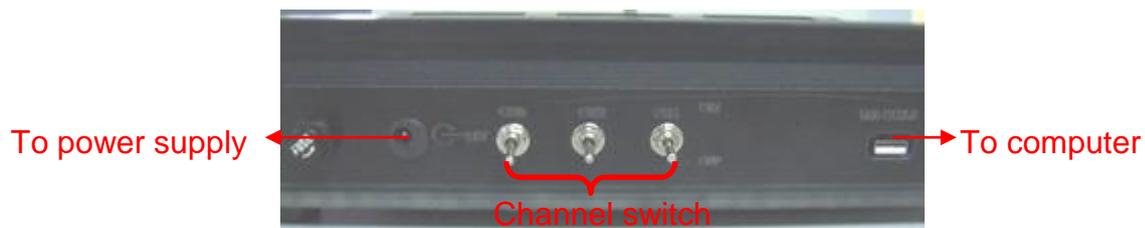
- 6) Connect power supply to the 12V connector.
- 7) Connect jig to the computer via USB cable.
- 8) Turn on the +12V switch and LED will turn on red.

- 1) The bench supports 3pcs channel downloading, but when you press the red button, at most 2 in one time.
- 2) Change for handset socket when you need handset downloading;
- 3) The socket can be replaced when you want to download other MTK product without change the bench.

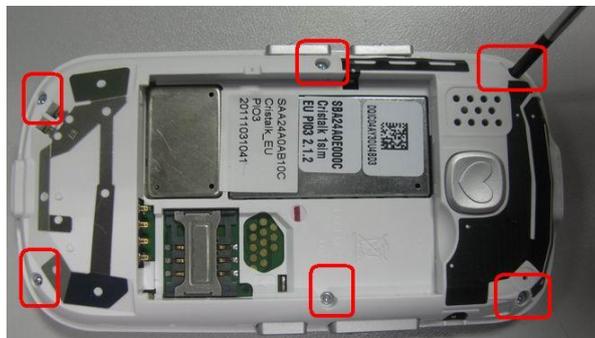
Step 1: Remove the 6 screws from the decorate frame by screw driver.

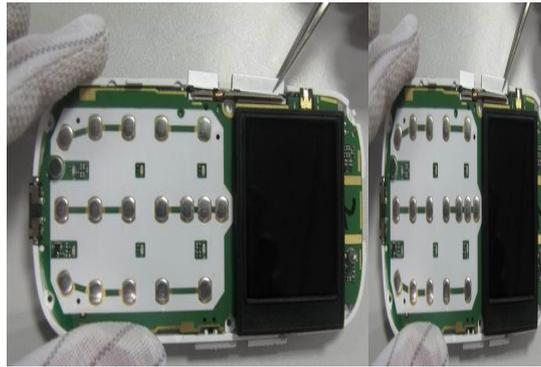
Step3: Remove keypad and receiver.

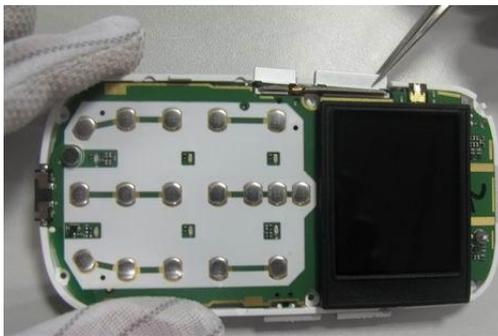
Step4: Separate the side key and then remove the PCBA from Front frame.

Note: please use brush to smear the lube at the undersurface of slide keys before assembling a new furnished frame. And move the slide keys back and forth (at least once) after smearing the lube. Otherwise, the slide keys can work but maybe hard to move.

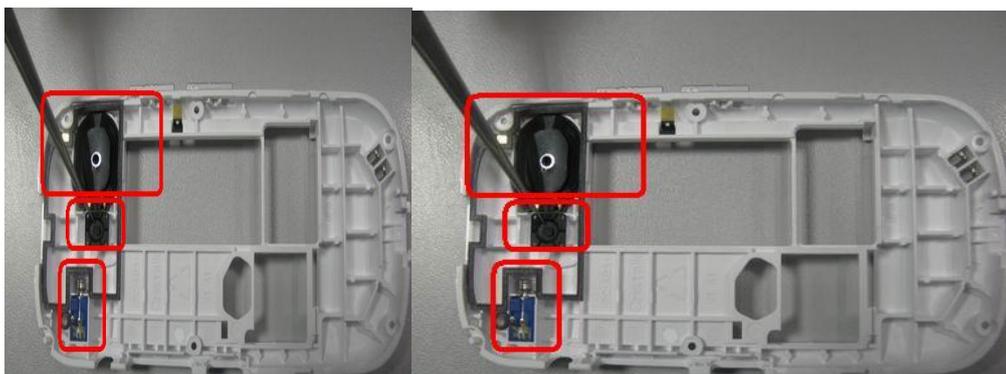
Step5: Separate the LCD rubber/vibrator/speaker/SOS rubber.

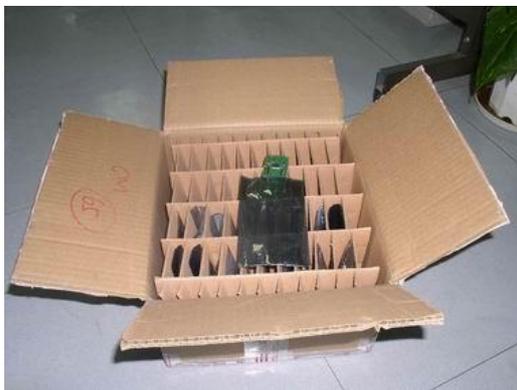
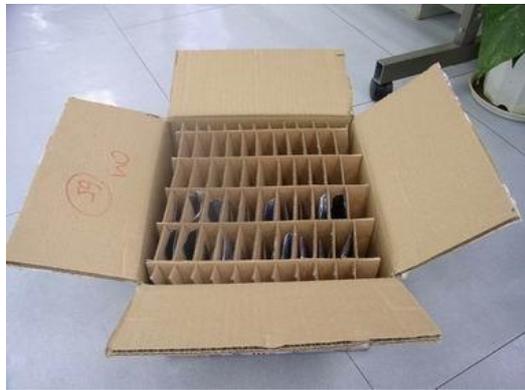
- 1) PCBA shipment requirement:
 - Anti Electro-Static.
 - Avoid PCBA are laid to overlap each other.
 - Against press outside package.
- 2) Solution 1: Each PCBA is packaged by shield bag, put each PCBA into each cave of the carton (refer to picture below).

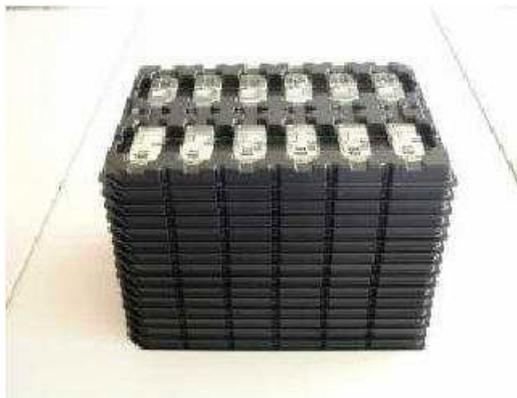
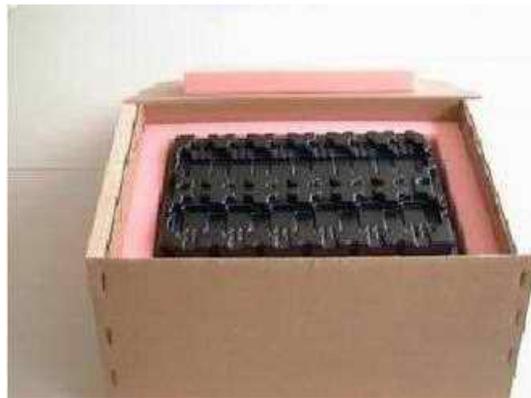
- 3) Solution 2: Stack by special trays (15 trays maximum), put empty trays to fill space inside the carton and all trays should be bound tightly in order to avoid PCBA move out (see picture below).
