# ZU1 SYSTEM BLOCK DIAGRAM

PROJECT : ZU1  
Quanta Computer Inc.

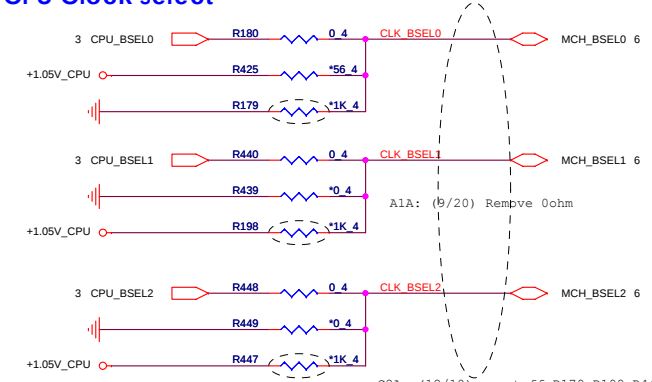
CPU Clock select

C2A: (12/10) no stuff R179, R198, R447 for auto CPU frequency selection (follow ZD1, Z01)

E3A: (3/16) Change C542 from 0805(CH6102K9A01) to 0603(CH6101K9905) base on ME request (HDD Mylar issue)

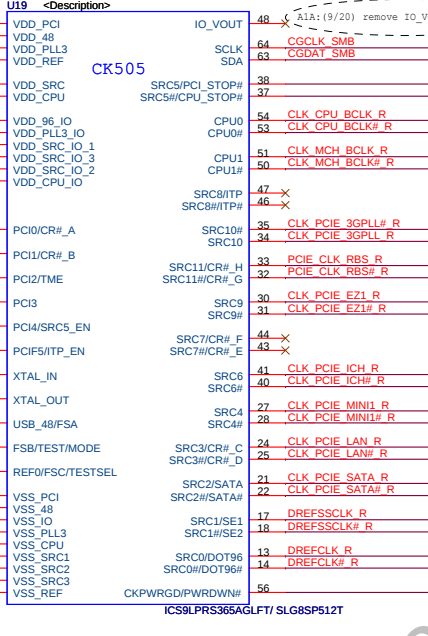
ICS9LPRS365BGLFT  
SLG8SP512T: AL8SP512K05

<check list>  
(1)PCI2/TME: PU be used, the CK505 cannot over clock any of the clock for Trust Mode security purposes.  
(2)PCI4/SRC5\_EN: PU be used, the CK505 will be configured to use Pin37/38 to SRC5 clock. If PD be detect at powe-on, the CK505 will setting Pin 37/38 to PCL\_STOP/CUP\_SOTP (Default is setting to PCL\_STOP/CUP\_SOTP)  
(3)PCIF5/ITP\_EN: PU be used, the CK505 will be configured to use Pin46/47 to CPU ITP clock. If PD be detect at powe-on, the CK505 will setting Pin 46/47 to SRC8 (Default is setting to SRC8)  
(4)SLG8SP512 Pin 6 select Pin 17, 18 output is LCDCLK or 27 M, PD is LCDCLK, PU is 27 M, Pin 37, 38 will fixed be use CPU\_Stop and PCL\_Stop.  
(5)SLG505Y64 CK505 Standard parts follow standard setting

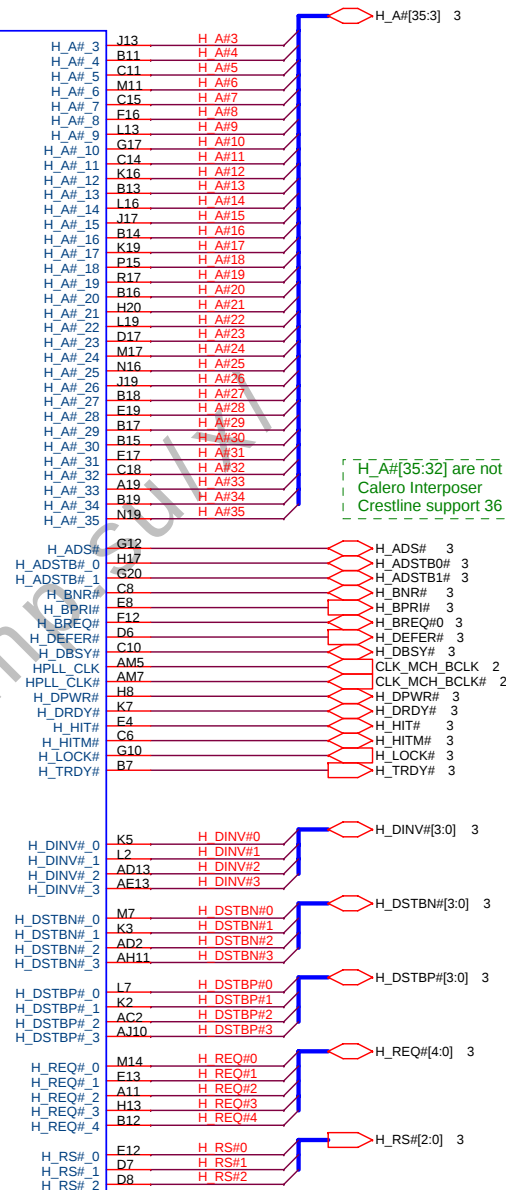
HOST

H\_A#35:32 are not supported in  
Calero Interposer  
Crestline support 36 bit address

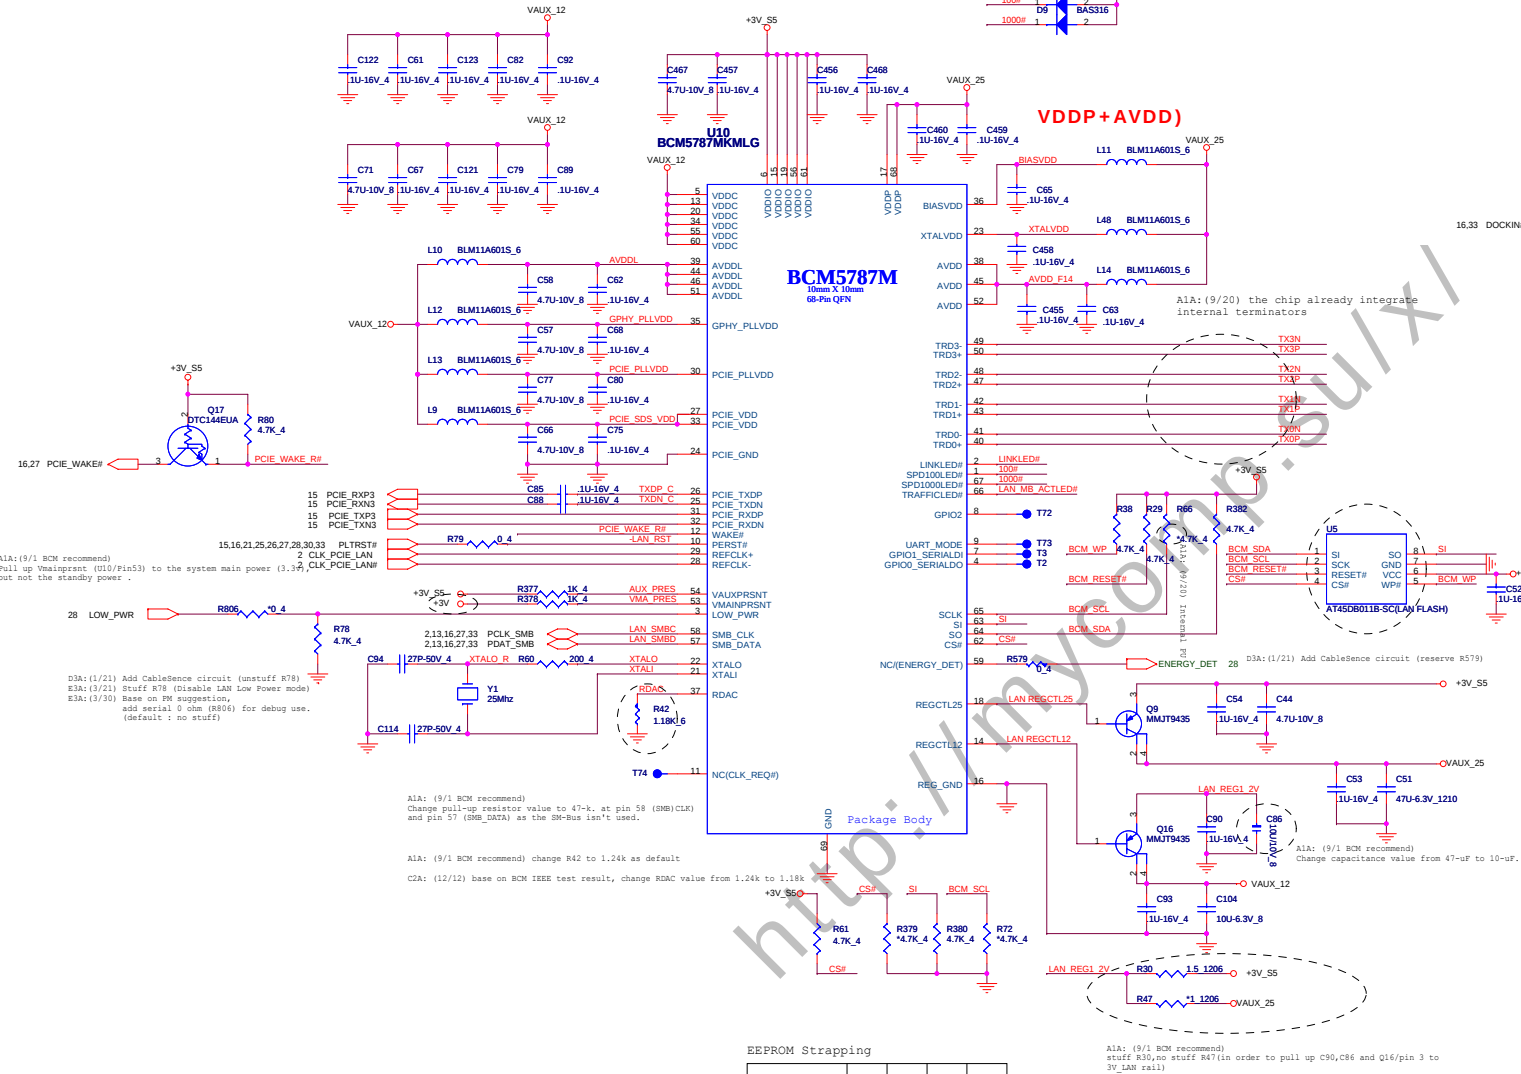
# Giga LAN BCM5787M

A1A: (9/27) Change +3V\_LAN\_S5 to +3V\_S5

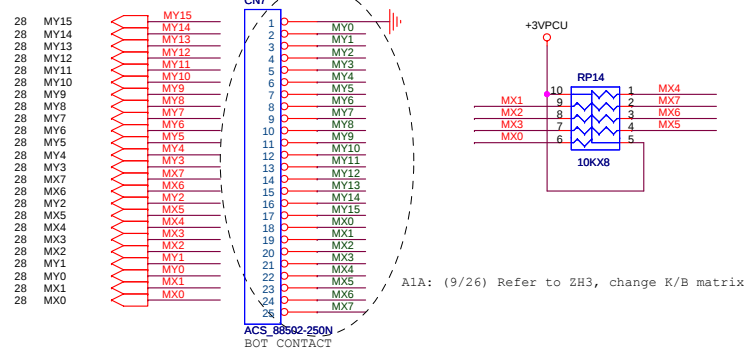
INT K/B

A1A: (9/26) Refer to ZH3, change K/B matrix

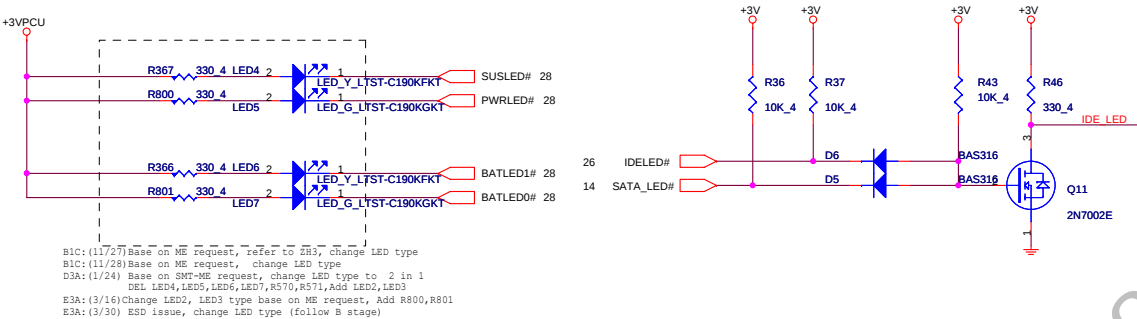
B1C: (11/27) Base on ME request, refer to ZH3, change LED type  
B1C: (11/28) Base on ME request, change LED type  
D3A: (1/24) Base on SMT-ME request, change LED type to 2 in 1  
D3A: (1/24) LED4, LED5, LED6, LED7, R570, R571, Add LED2, LED3  
E3A: (3/16) Change LED2, LED3 type base on ME request, Add R800, R801  
E3A: (3/30) ESD issue, change LED type (follow B stage)

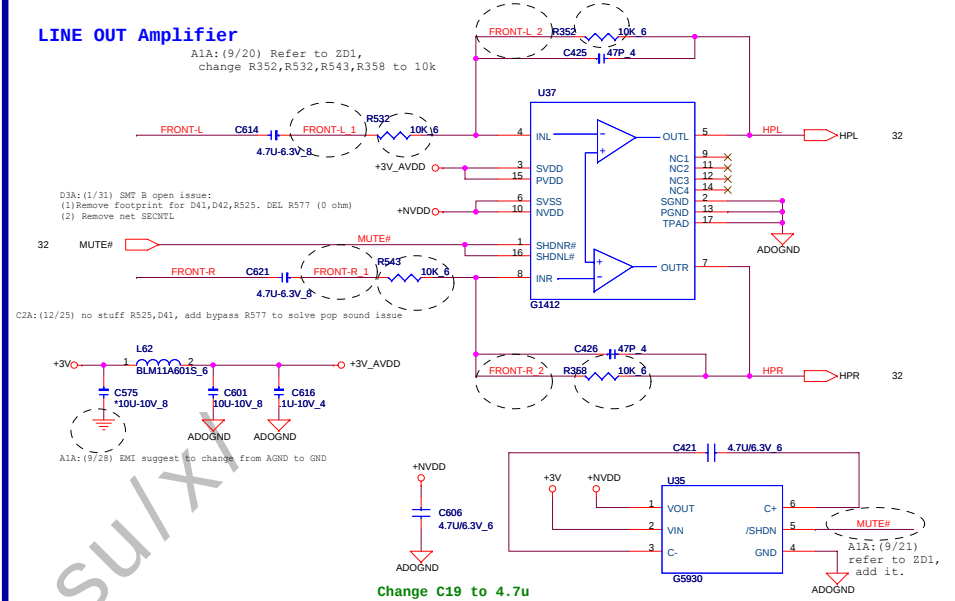
## LINE OUT Amplifier

A1A: (9/20) Refer to ZD1,  
change R352,R532,R543,R358 to 10k

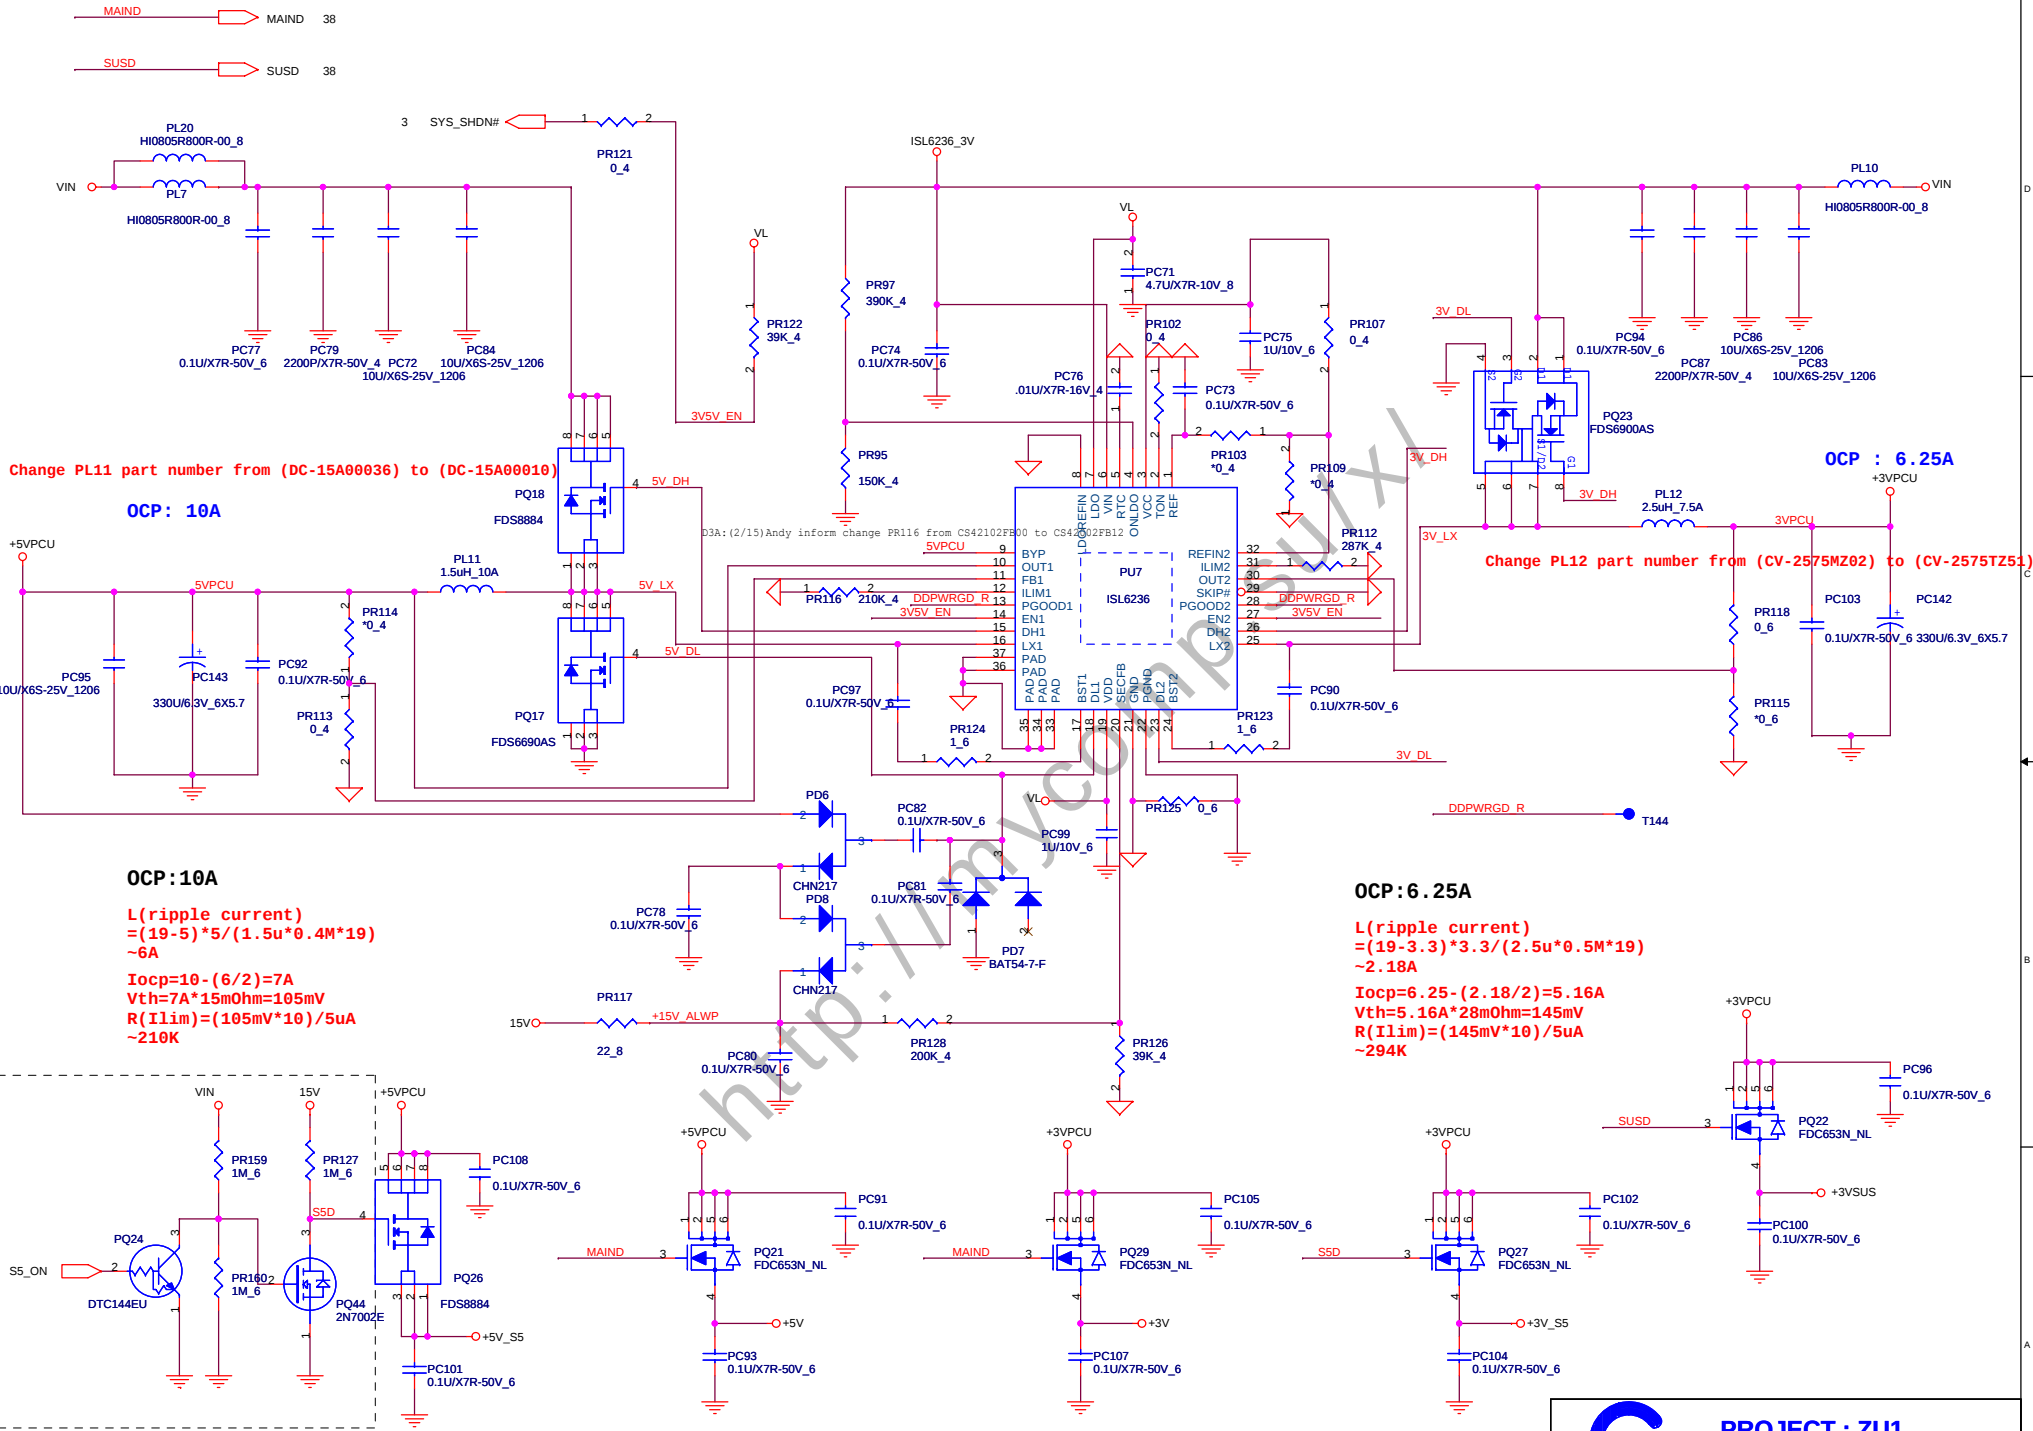
Change PL11 part number from (DC-15A00036) to (DC-15A00010)

OCP: 10A
