# LBK-ADDs Schematic

DDQ12/LA1901 Schematic with Capture CIS and Function field  
uFCPGA Banias  
06-24-2003  
REV: 1.0

| <b>Cover Sheet</b> | | |
| | <b>DDQ12/11/01 with LA-1901</b> | <b>1.0</b> |

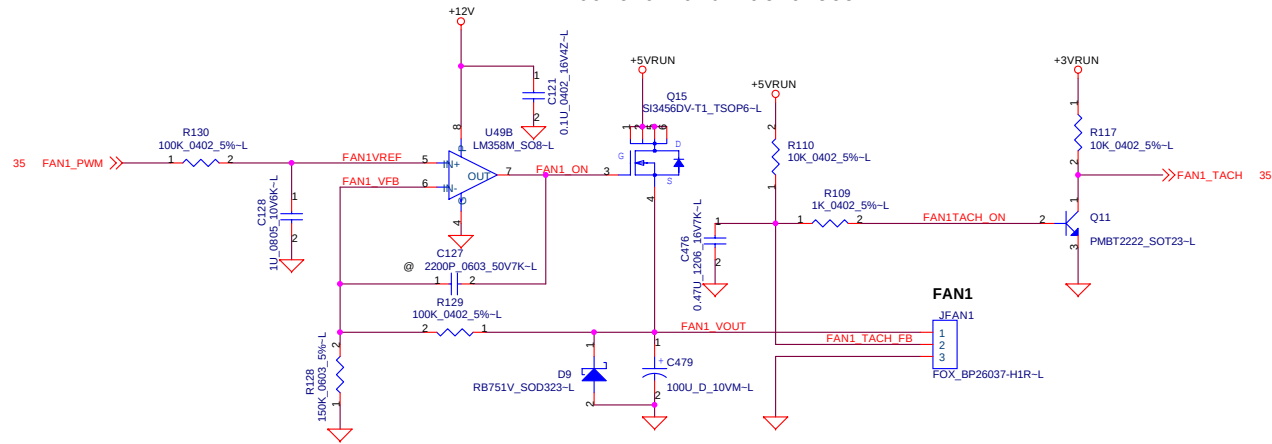
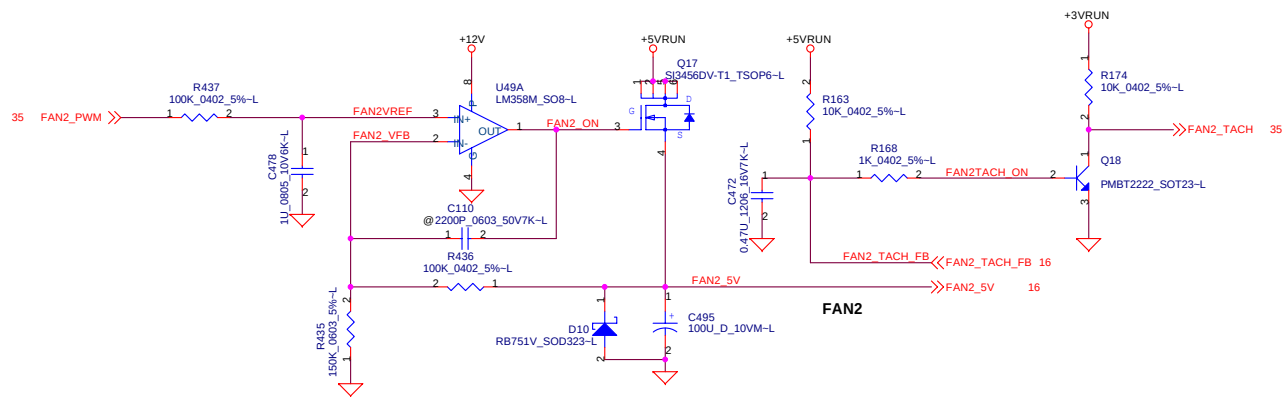
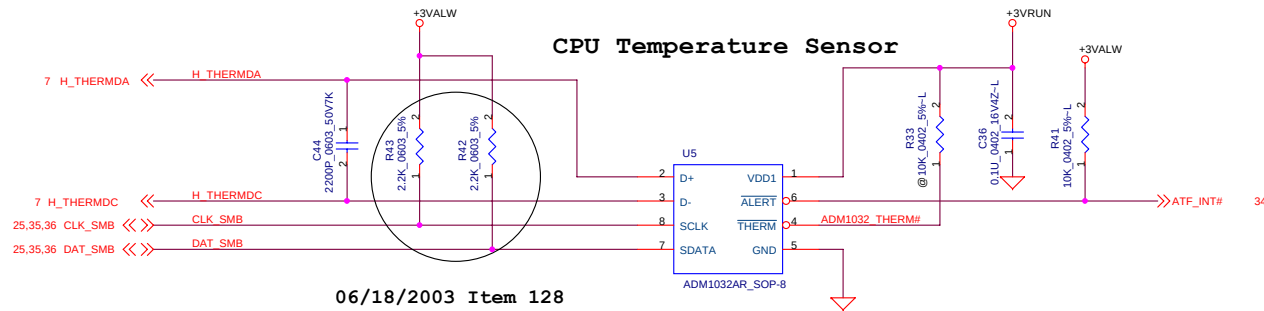
# FAN1 Control and Tachometer

ITP Debug CONN. & FAN

| Item | Page# | Title | Date | Request Owner | Issue Description | Solution Description | Rev. |
|---|---|---|---|---|---|---|---|
| 30 | 13 | Fan soft<br>start | 10/17/2002 | Compal | No soft start will cause +5VRUN droop low | change C127 and C110 pop(don't do it per Bo's command) | X01 |

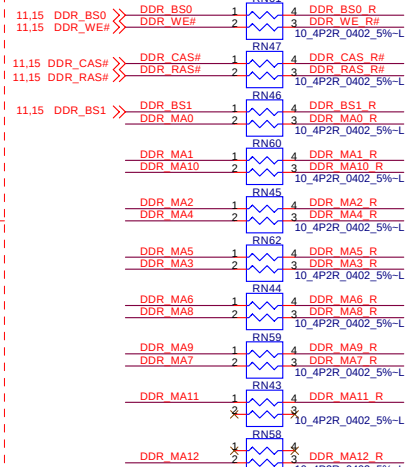
**DDR-SODIMM SLOT1**

**Layout Note:**  
Place these resistor  
closely DIMM0,all  
trace length<750 mil

**Layout Note:**  
Place these resistor  
closely DIMM0,all  
trace length  
Max=1.3"

**DIMM0  
STANDARD**

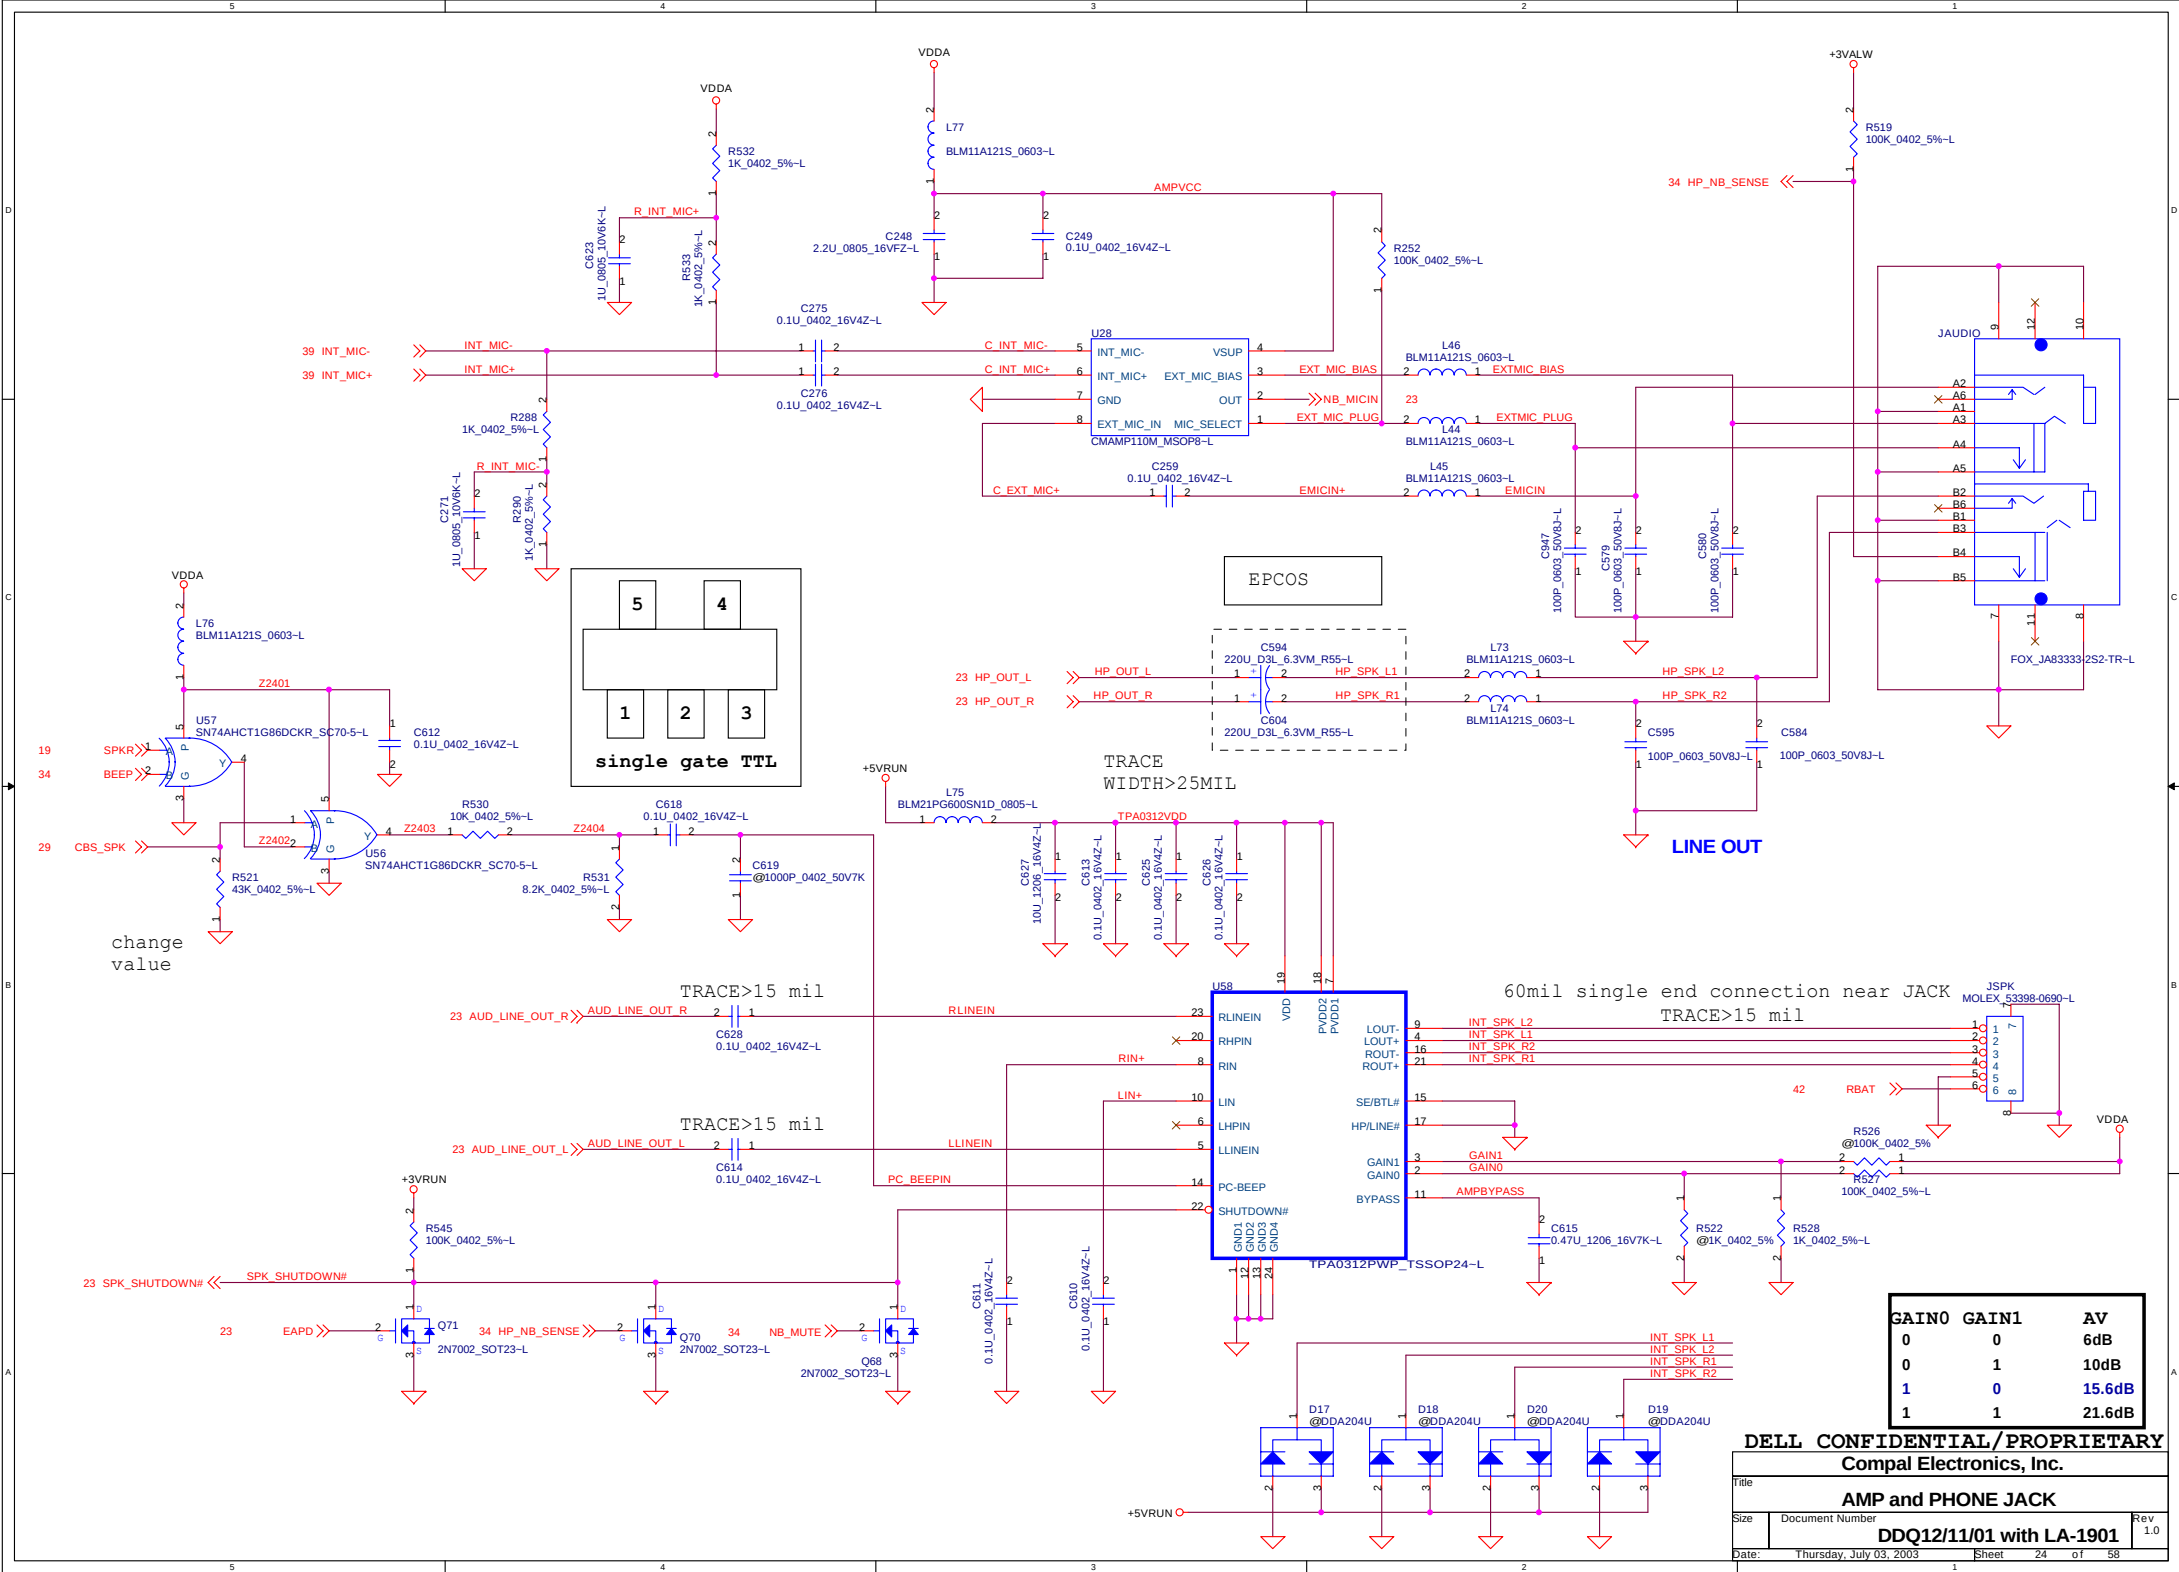
| AMP and PHONE JACK | | |

| GAIN0 | GAIN1 | AV |
| 0 | 0 | 6dB |
| 0 | 1 | 10dB |
| 1 | 0 | 15.6dB |
| 1 | 1 | 21.6dB |

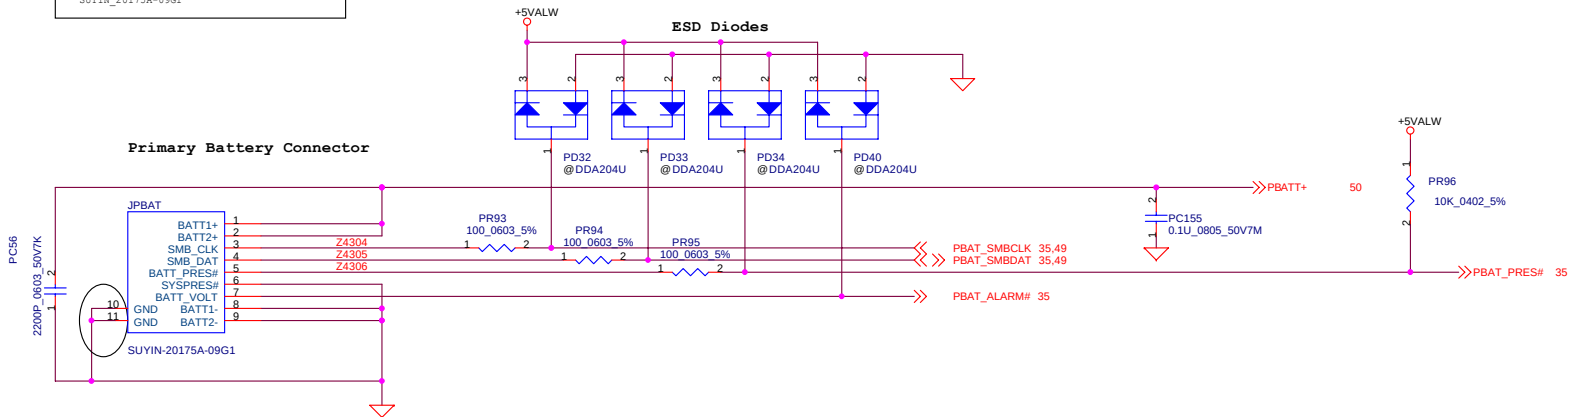
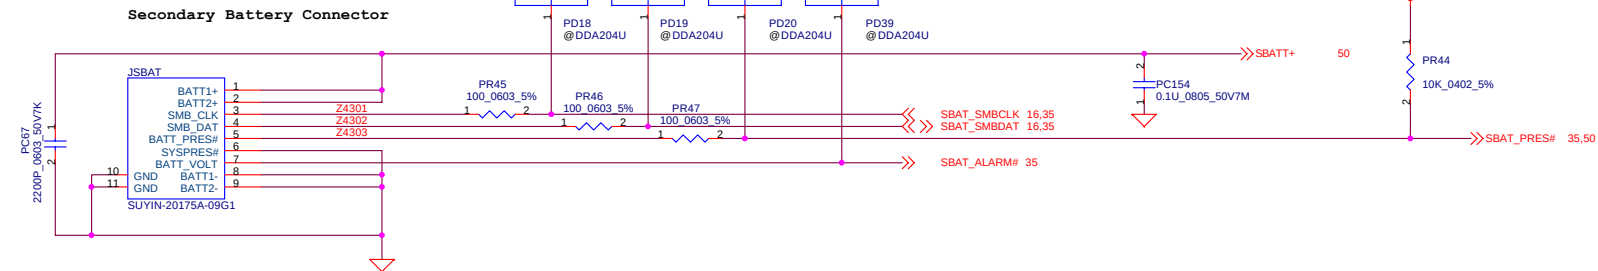
Title: SCHEM,PLN,MN,KAPALUA II Battery CONN.

SUYIN\_20175A-09G1

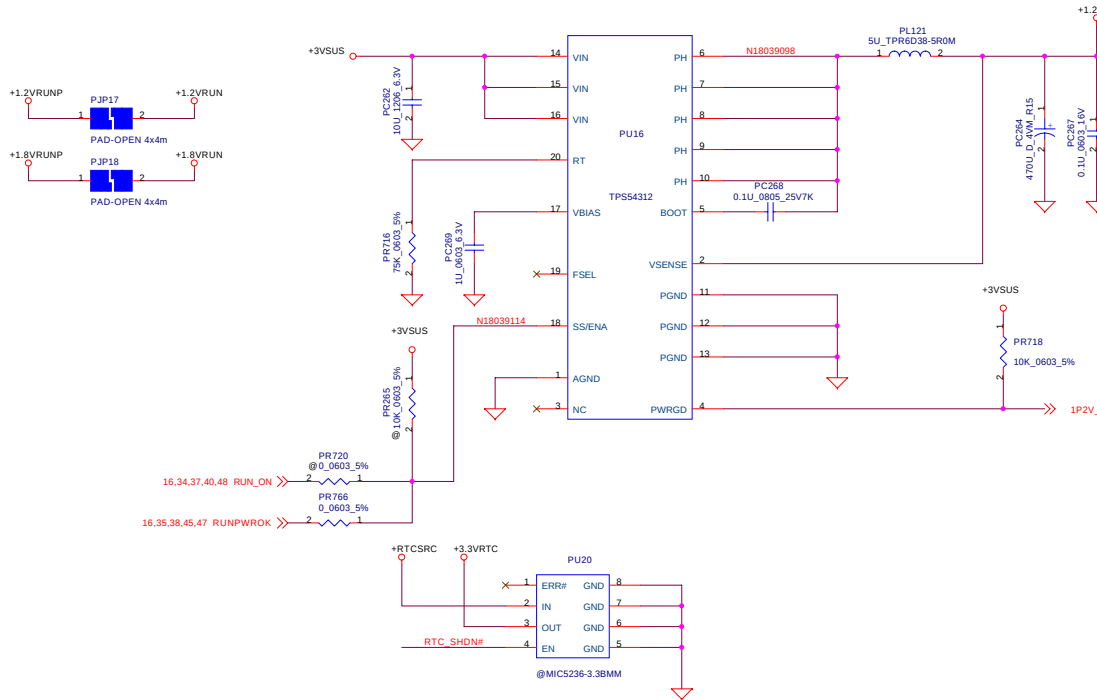
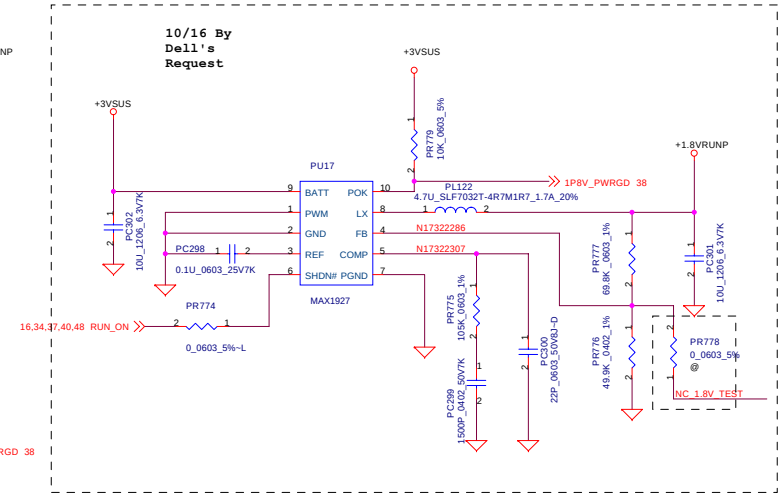
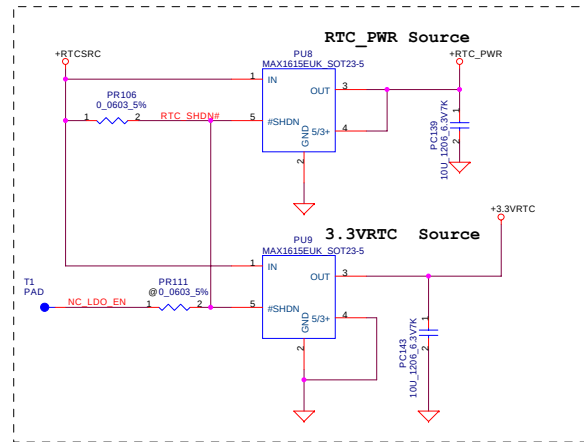
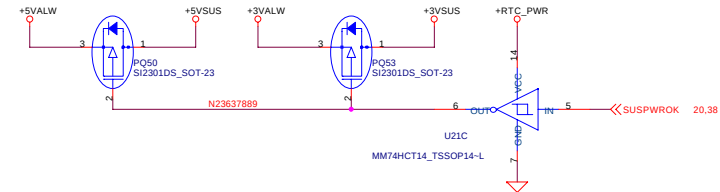
# +1.2VRUN/+1.8VRUN SOURCE

Allows SUS planes to power ALW planes when possible

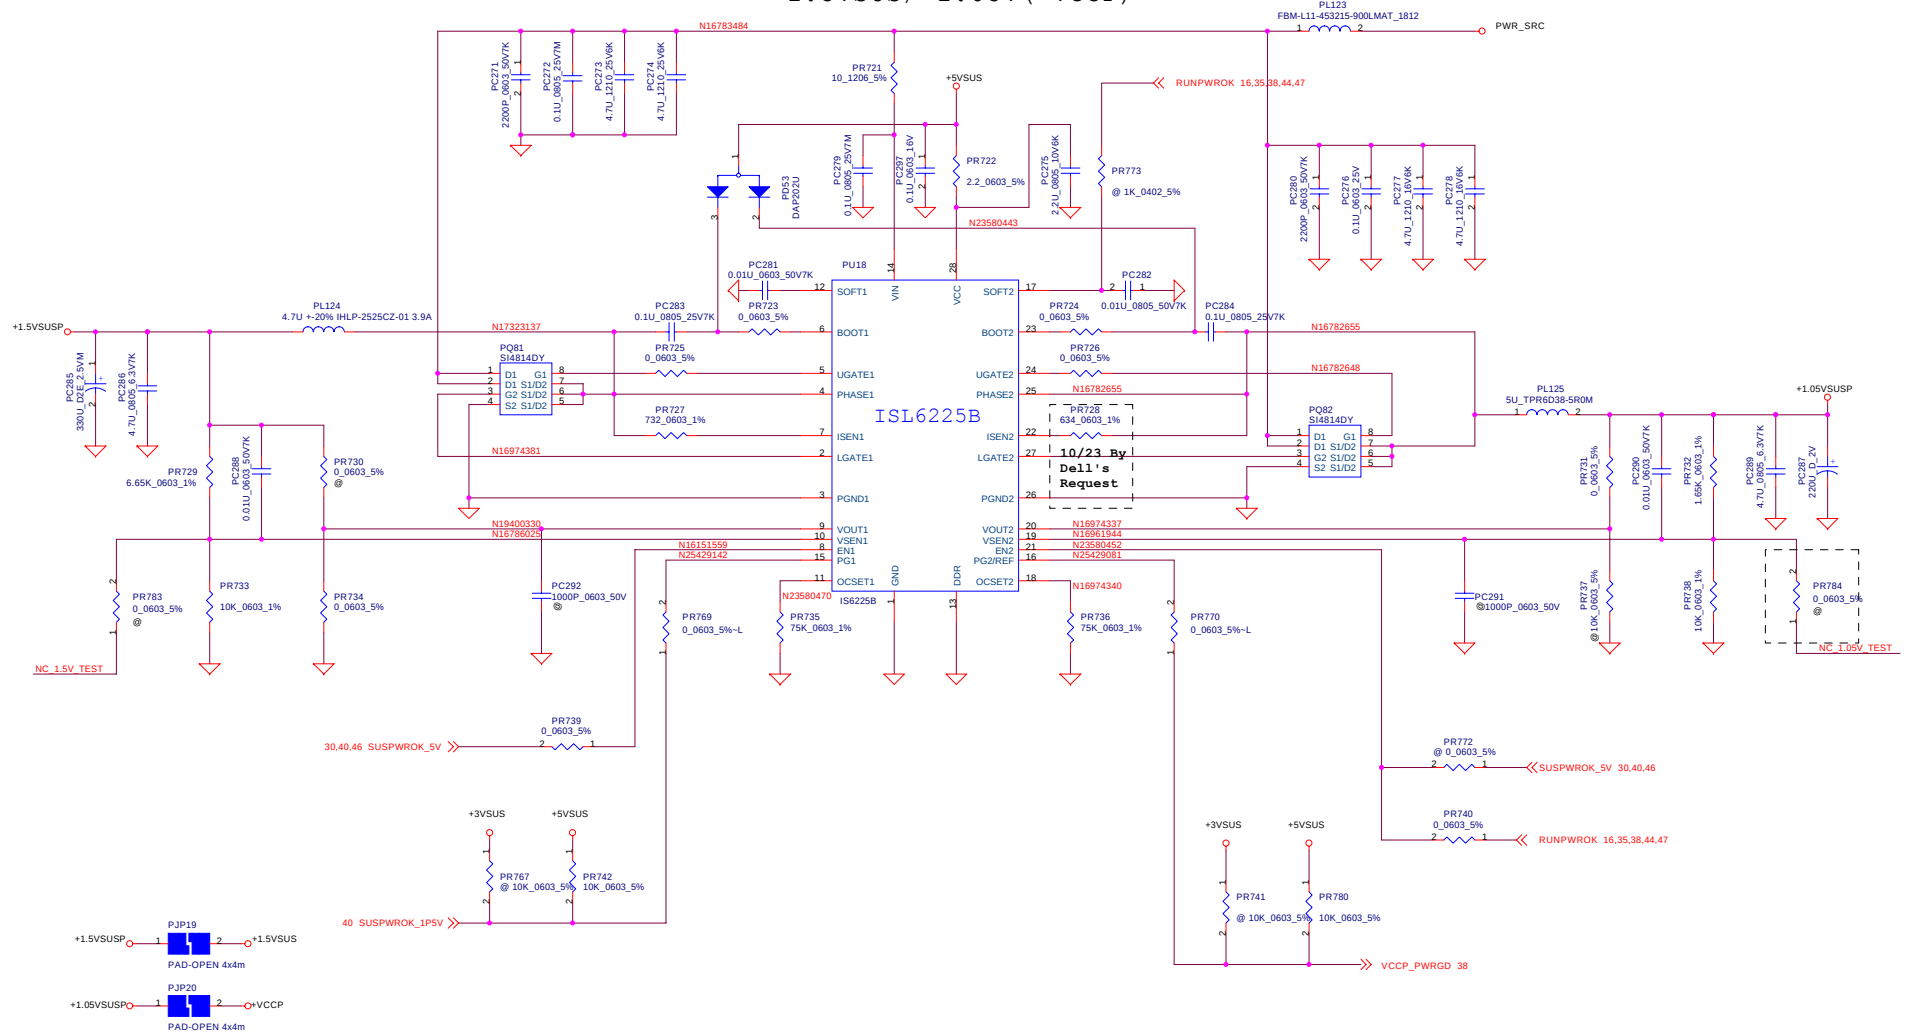
| Title | SCHEM,PLN,MN,KAPALUA II +1.5V & +1.05V | | |

+1.5VSUS/+1.05V (+VCCP)

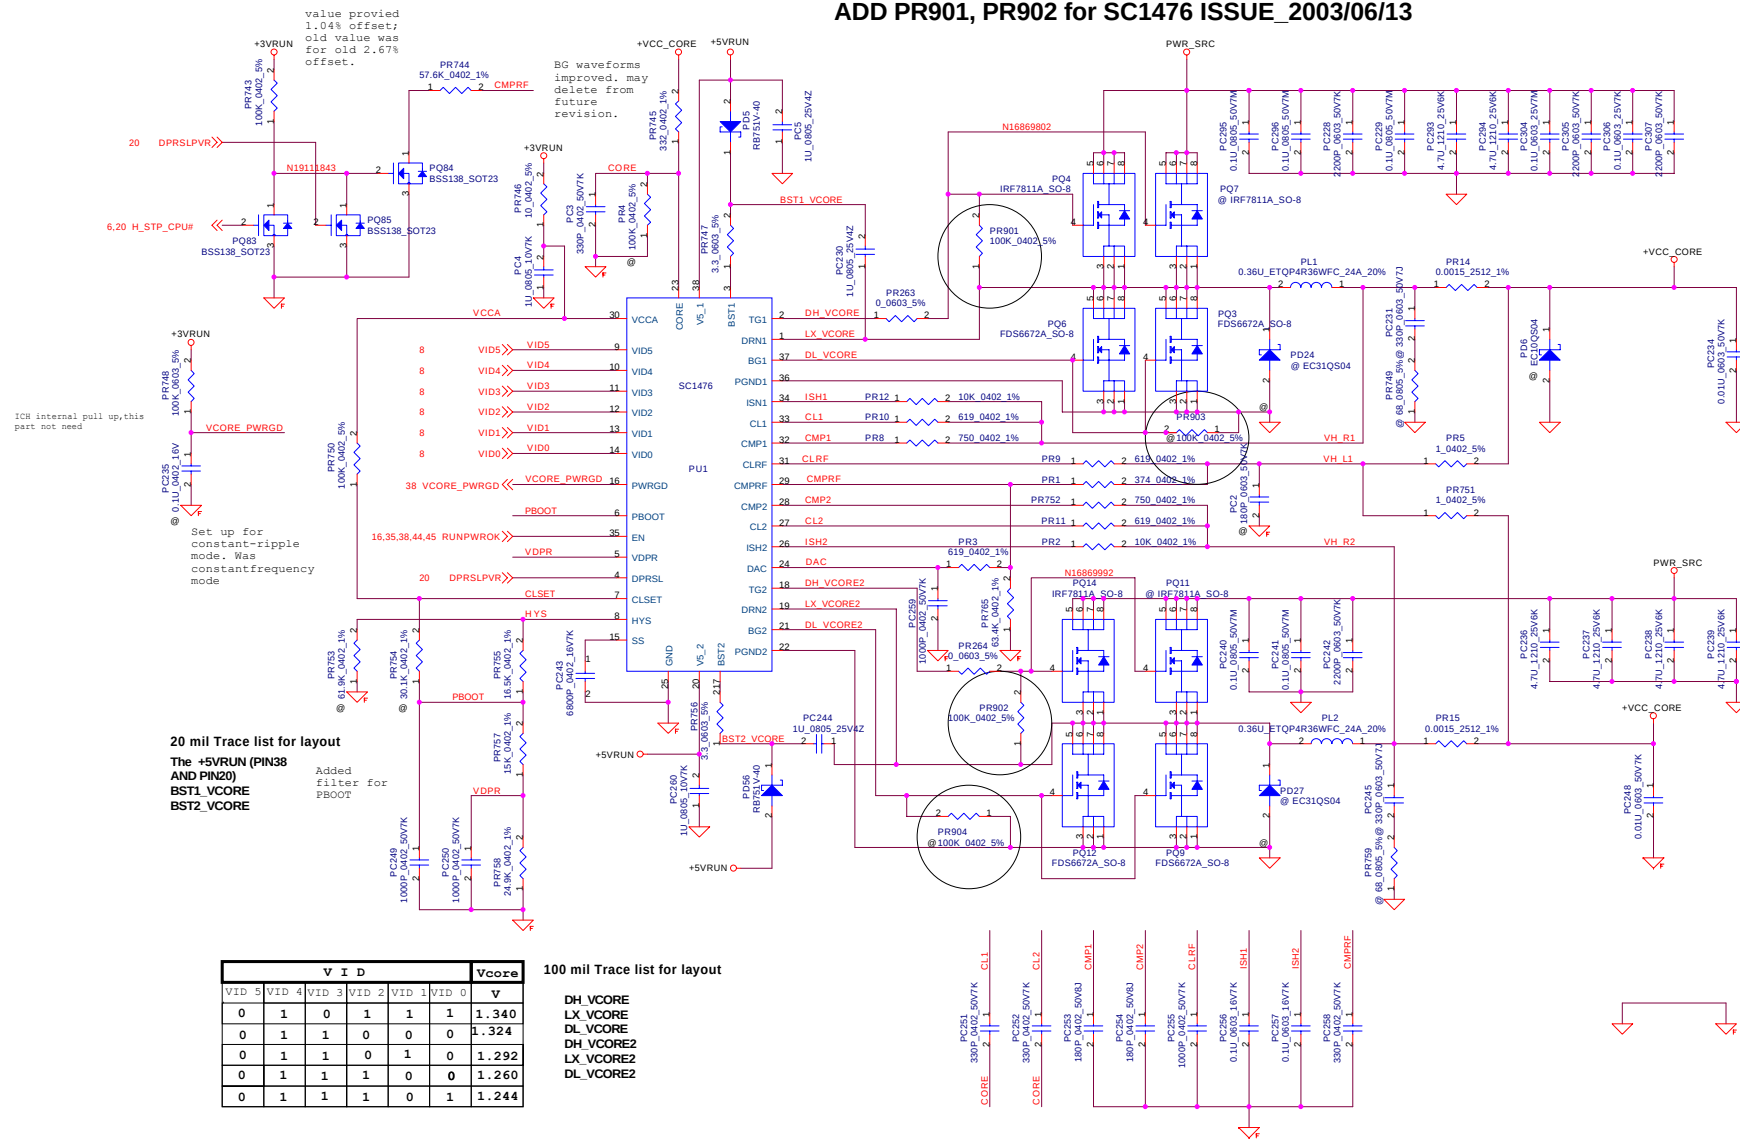
**ADD PR901, PR902 for SC1476 ISSUE\_2003/06/13**

| V I D | | | | | | Vcore |
| VID 5 | VID 4 | VID 3 | VID 2 | VID 1 | VID 0 | V |

### 100 mil Trace list for layout

DH\_VCORE  
LX\_VCORE  
DL\_VCORE  
DH\_VCORE2  
LX\_VCORE2  
DL\_VCORE2

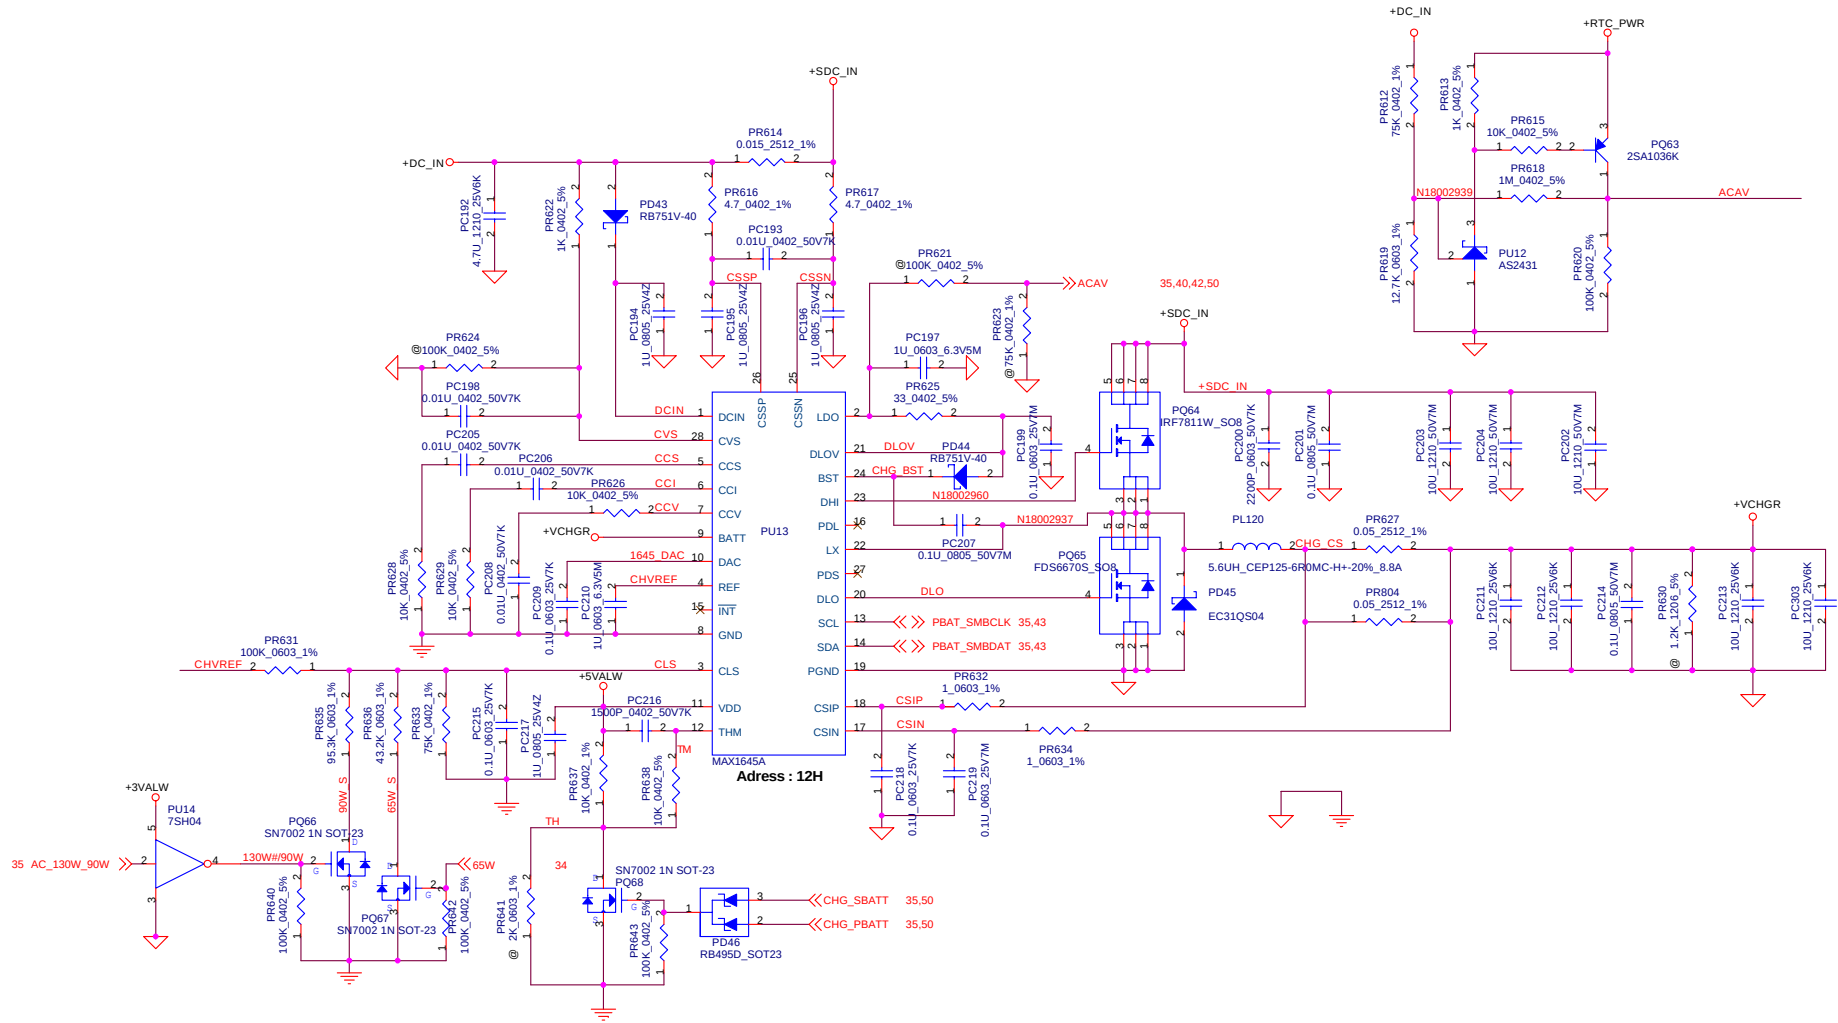
Title  
**SCHEM,PLN,MN,KAPALUA II CHARGER CONTROL**

| | 65W<br>(2.93A) | 90W<br>( 4.0A ) | 130W<br>( 5.85A ) |
| 65W | H | L | L |
| AC_130W_90W | H | L | H |

| Item | Page# | Title | Date | Request Owner | Issue Description | Solution Description | Rev. |
|---|---|---|---|---|---|---|---|
| 36 | 49 | Chagrger | 03/05/2003 | Compal | To Reduce RTC Bridge Battery Leakage Current (Changed Power Plane from +RTC_PWR to +5VALW) | PU13. PC216, PR637, PC217, Depop PR641 | A01 |
