# LKB-ADDs, Plus Schematic

DDQ12/LA1901 Schematic with Capture CIS and Function field  
uFCPGA Banias  
01-02-2004  
REV: 3.0

| | DDQ12/12/01 with LA-1901 | 3.0 |

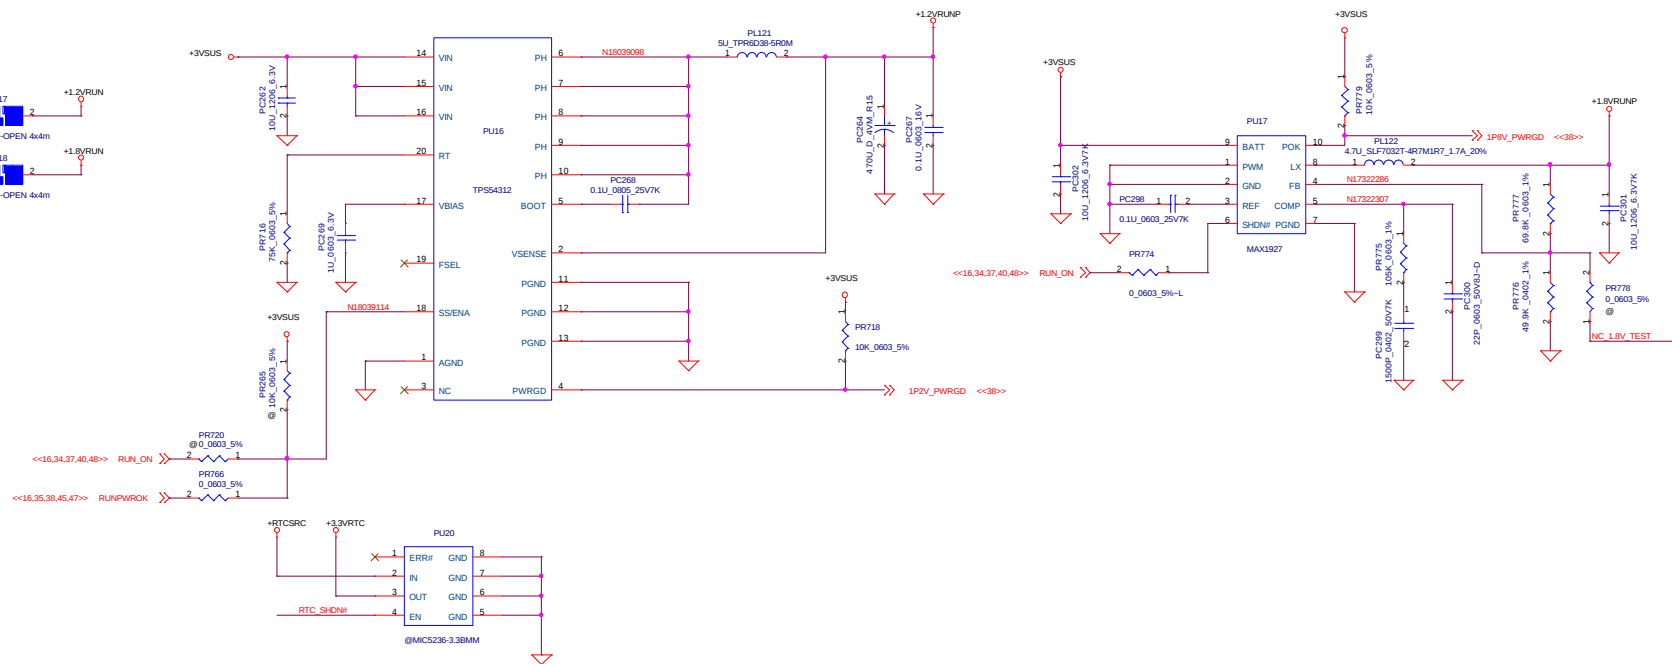
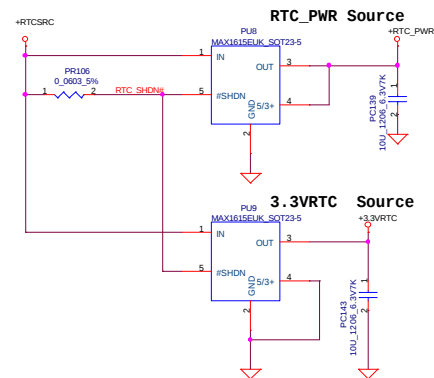
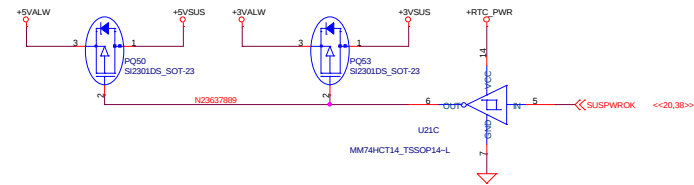
## +1.2VRUN/+1.8VRUN SOURCE

Allows SUS planes to power ALW planes when possible

| Title | SCHEM,PLN,MN,KAPALUA II +1.2V & +1.8V |
